Building Inspection for MEP Systems
Food World Building
6032 Hwy. 90
Milton, FL

July 8th, 2016

General Overview

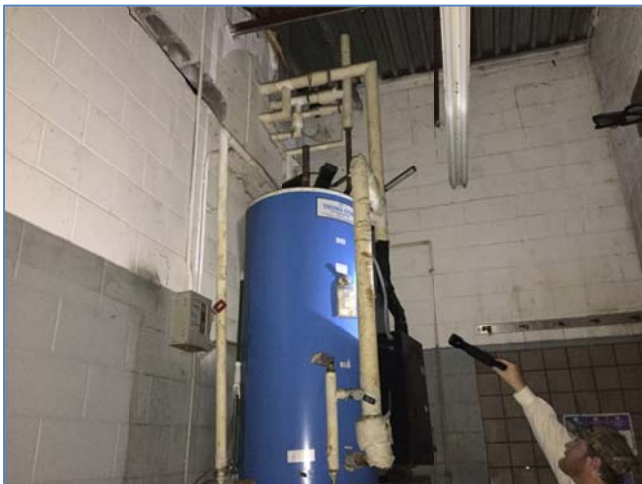
Existing water heater located back of house.

The domestic hot water heating system is composed of an electric water heater with heat recovery tank located at the back of house area on the NW portion of the building. This unit has not been operational for several years and is considered to be past its' useful life. Replacement of the domestic hot water heating system is recommended, however a replacement cost is not able to be determined at this time as the new system will be contingent on the layout of the renovated building spaces.

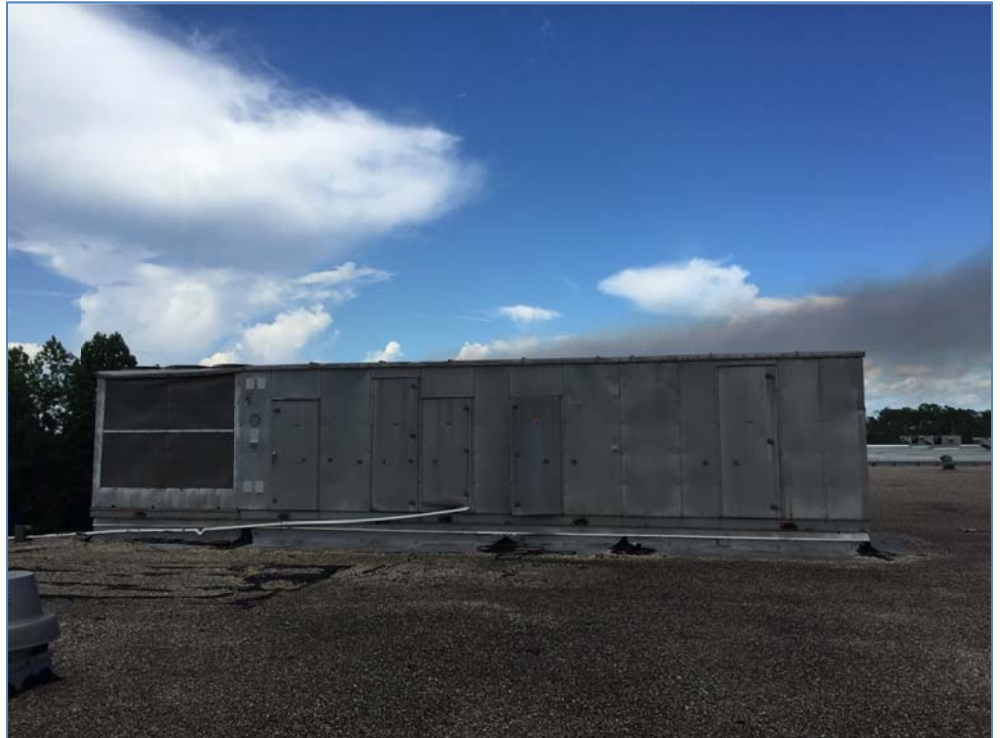
The majority of the building is served by a single custom packaged rooftop unit (Seasons-4). This unit is in poor condition and is past its estimated useful life. In addition, the unit utilizes the older R-22

Existing unit on rooftop.

refrigerant based equipment which has been phased out of commercial production for several years, which would further exacerbate maintenance issues in the future. It is recommended that this unit be replaced with equipment that meets the new energy efficiency requirements.

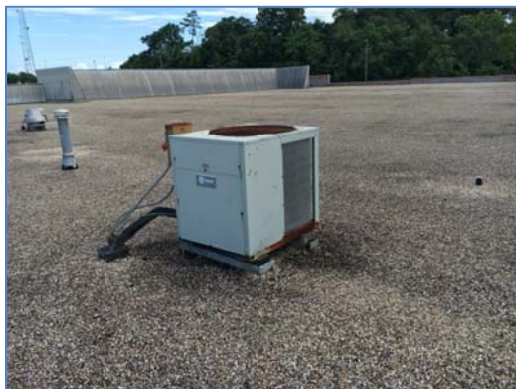
Existing split system condensing unit on rooftop.

The second split system unit is in similar condition, and again operates with the older refrigerant type. It is recommended that this unit be removed and the areas originally served by this unit be consolidated in with the new system recommended above.

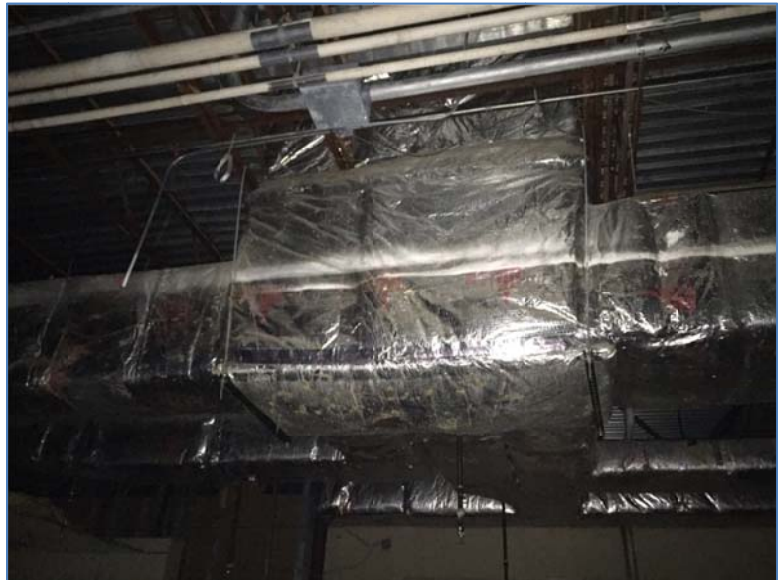
The supply and return ductwork installed within the facility was exterior wrap ductwork that was noted to be in fair condition on the exterior, however the interior of the ductwork is very dirty from the limited observations available. Furthermore, evaluation of the existing air devices indicates dirt markings on all of the supply and return registers. These observations, coupled with the lack of ventilation and cleaning over several years of non-operation and the requirement to replace the existing air conditioning system lead to the recommendation for removal of the existing ductwork system in its' entirety and replacement with a new externally insulated ductwork system.

Existing exterior wrap ductwork noted above existing ceiling.

The estimated replacement cost for the new HVAC system (including ductwork, equipment, and controls) is anticipated to be in the \$15-\$18 per square foot.

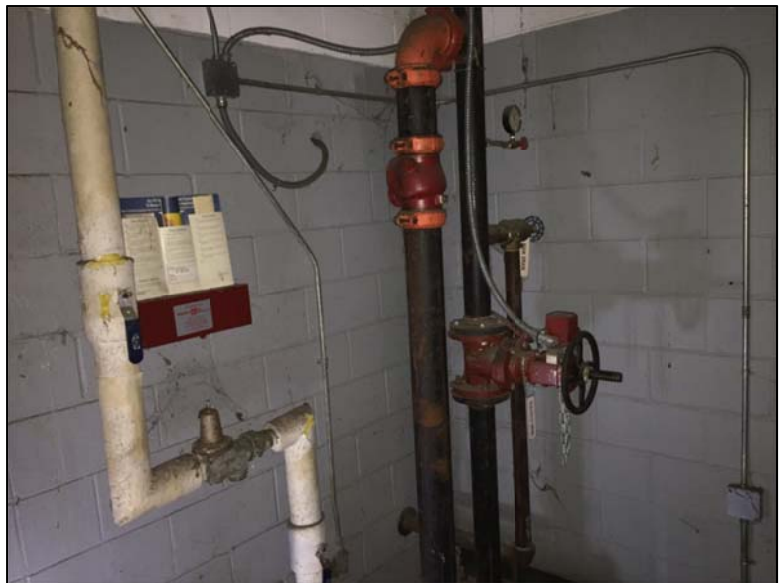
The existing fire suppression system serving the facility is a wet pipe system with the main riser located in the NE corner of the back of house area in receiving. The existing system is in good condition, however it is noted that the certification of the existing system does not appear to be current. Also, the existing system comes into the building as a 6" pipe and then reduces to a 4" fire riser and distribution main. Future system modifications may require upsizing the riser and/or main distribution piping based on current water flow test results. Estimated fire suppression system renovation costs would be in the \$2.00-\$3.00 per square foot range.

Existing fire riser.

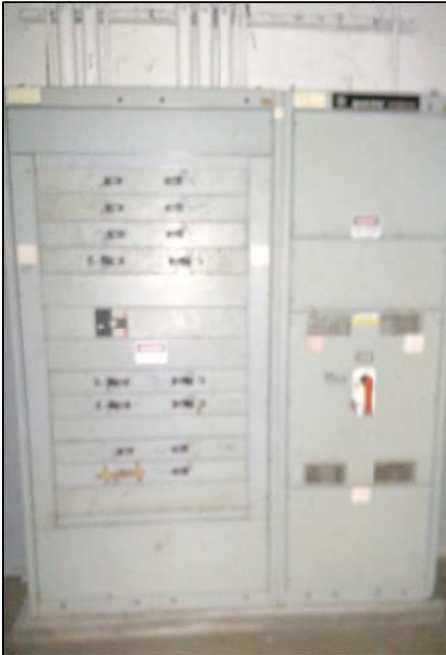
The building was currently fed from an existing 1600A GE Spectra Series 480V switch board that serves the large mechanical equipment loads and lighting. There are dry-type step down transformers currently suspended from the existing structure that serve the 208Y/120V panelboards which serve the receptacle loads. The 1208Y/120V panelboards are located primarily in the rear of the building adjacent to the main switchboard. There are a few other panels located in the bakery, meat processing and admin areas. The existing main switchboard and most of the existing panelboards are in good condition and new circuit breakers are available for them to serve new loads.

Existing main GE electrical gear.

It is recommended that these panels and switchboard be reused to the greatest extent possible. New panelboards would have to be provided to serve additional loads where necessary. It is further recommended that the existing dry-type transformers be removed and replaced with new transformers. The new transformers would be located in new electrical rooms distributed throughout the building to serve the loads in the areas where there are located. Estimated interior power costs would be in the \$7.50-\$9.00 per square foot range.

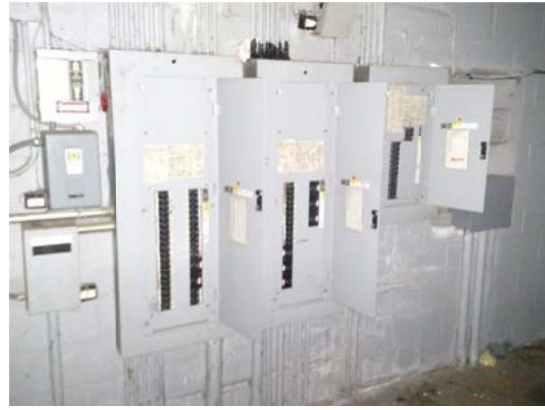
Example of panelboards.

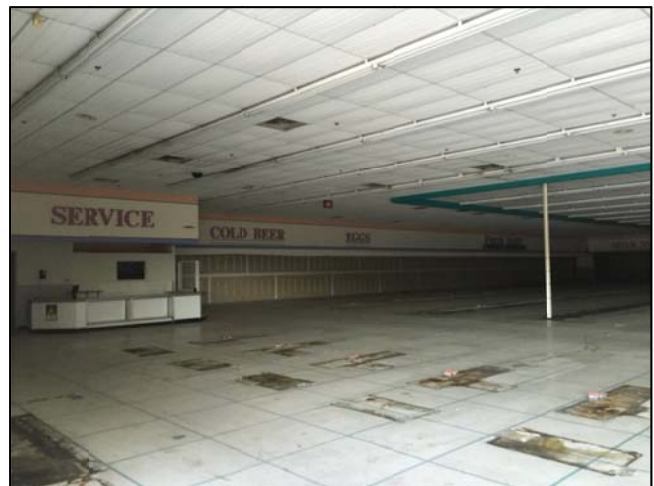
The majority of the lighting throughout the building consists of T8 and T12 fluorescent fixtures with some incandescent decorative fixtures in a few locations. The majority of the lighting fixtures are linear fluorescent strip lights. The strip lights do not provide adequate lighting for an office type environment. It is recommended that all of the lighting fixtures be removed and replaced with new LED lighting fixtures. The LED lighting fixtures will provide energy savings as well as reduced maintenance. Estimated interior lighting

Example of existing fluorescent strip lighting fixtures.

costs would be in the \$3.50-\$5.00 per square foot range. The existing parking lot lighting appears to be in good condition and operational. There may be a few fixtures that require lamp or ballast replacement. It is recommended that all of the parking lot lighting fixtures and pole remain and be reused.

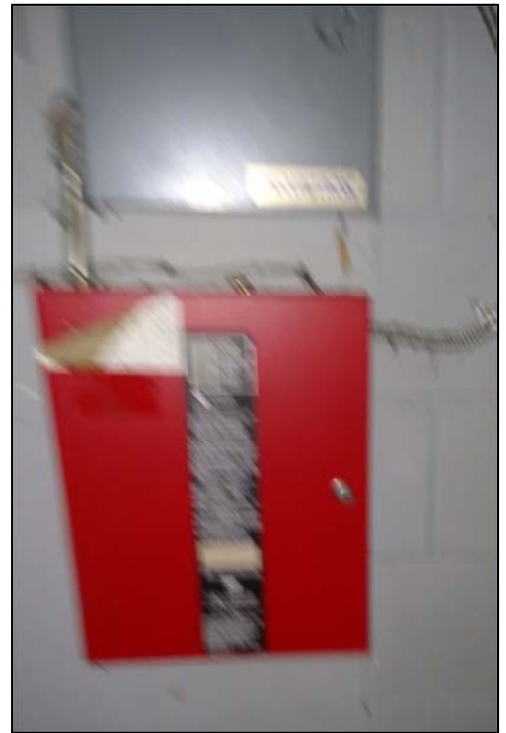
The existing fire alarm system is a FCI zone system. The existing system is outdated and cannot be expanded. It is recommended that the fire alarm system be removed in it's entirety and be replaced with a new multiplexed addressable fire alarm system with new devices as required on the renovated floor plan. Estimated fire alarm system costs would be in the \$3.00-\$4.00 per square foot range.

Existing fire alarm system.
