Jay Elementary School

BUILDINGS 2, 10 AND 15
EXISTING CONDITIONS AND CASTALDI STUDIES

FEBRUARY 26, 2021

Santa Rosa County District Schools

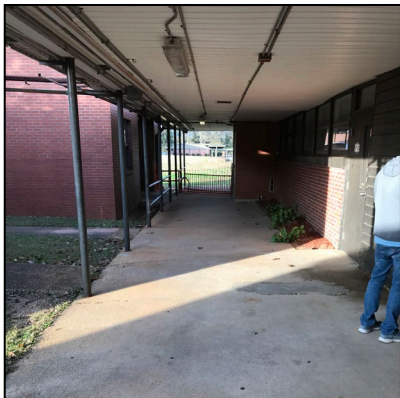
The covered walk on the south and east sides is in poor shape. Richard Laing the Supervisor of Building Maintenance stated that the existing roof has been replaced with a temporary one. There is evidence of some leakage from this roof.

Building 2 South side Canopy

6. Install new ceilings and lighting.
7. Replace the existing metal canopy on all sides.
8. Estimated Architectural and Structural repair and renovation cost: **\$250,000**

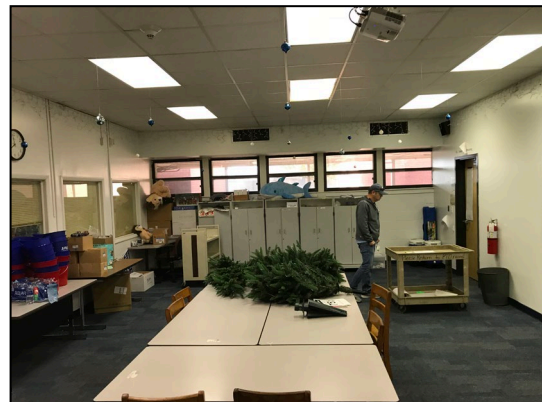
Building 2 Interior

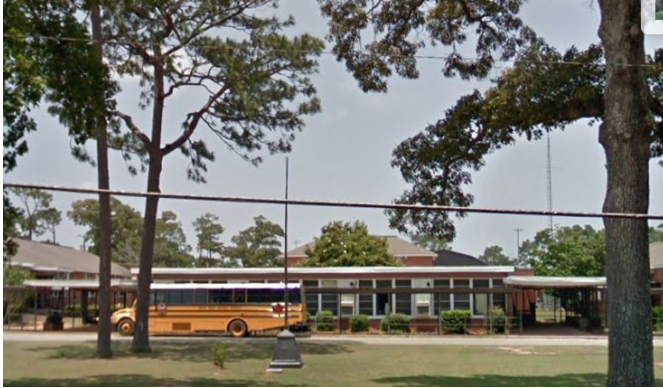
The windows appear to be the original single-paned ones from when the building was constructed. They need to be replaced. Exterior doors are worn and in need of replacement. There are pairs of doors to mechanical rooms on each end of the building. These doors need replacement. Flashing at some roof edges needs replacement.

Building 2 North Elevation

4. Replace existing windows with impact rated insulated window units.
5. Provide a new interior layout to fit the new spaces. This may include classrooms, offices, storage, and a mechanical and electrical room. The School District wants to replace rooftop units with a typical DX system so this will require condensing units on the ground around the building and an indoor unit in a mechanical room inside.

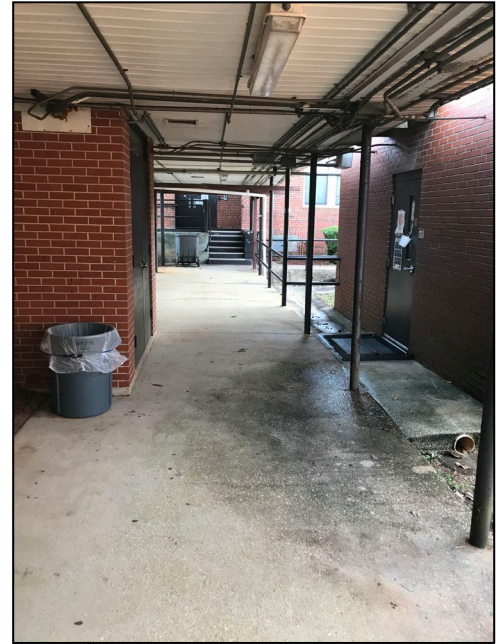
South side canopy

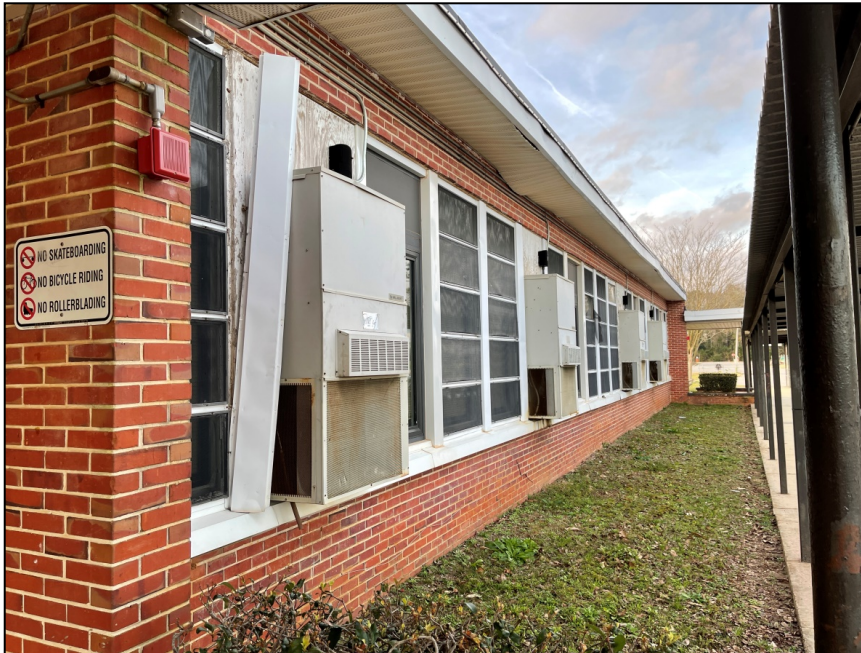
The existing systems are well beyond their useful service life. Typical median life of DX packaged equipment is about 15 years. These units are not up to current codes for ventilation, service, and safety standards. There is no control of indoor humidity or active dehumidification. The equipment condition and serviceable and should be replaced with new (for commercial refrigeration) or chilled water (for occupant cooling) as part of any substantial facility renovation

Building 2 - Current wall mount packaged units with no outside air ventilation to satisfy Florida Building Code.

1. Replace HVAC system serving this building complete with high efficiency unit. Provide building DDC (Direct Digital Controls) system with new code compliant system(s). System would need to be provided with modern BACNet architecture as part of any upgrade. Web based energy management software permits oversight of component status but provides limited to no ability to change set point or schedule operation.
2. The new system(s) will supply all spaces with the proper dehumidified outside air based on ASHRAE 62.1 standard.
3. All exhaust systems would be replaced and comply with current standard practices. A comprehensive review of the new systems would be performed in order to verify compliance with the 2020 FBC Energy Conservation Code.
4. Estimated repair cost = **\$150,000**

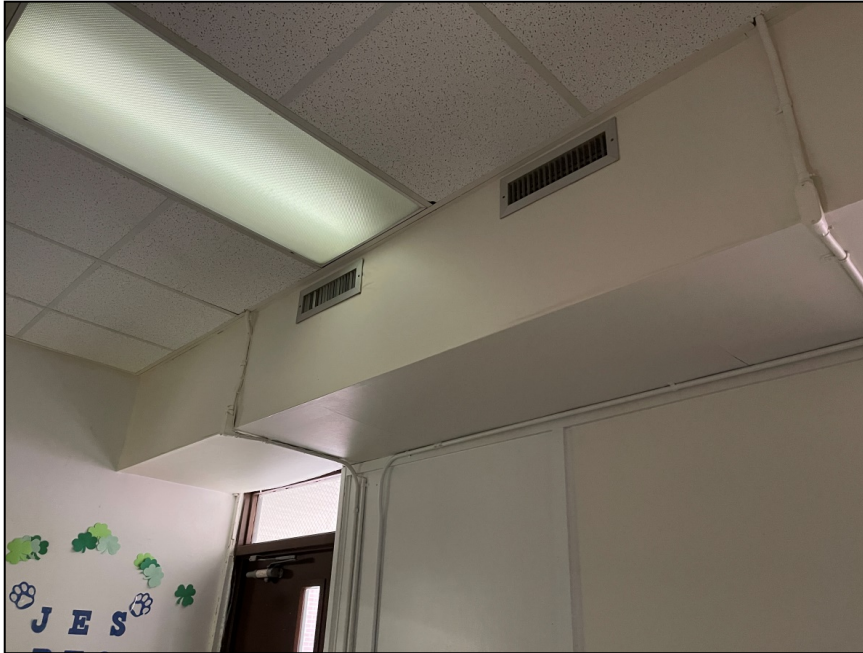
Building 2 - Abandoned supply grilles and ductwork system

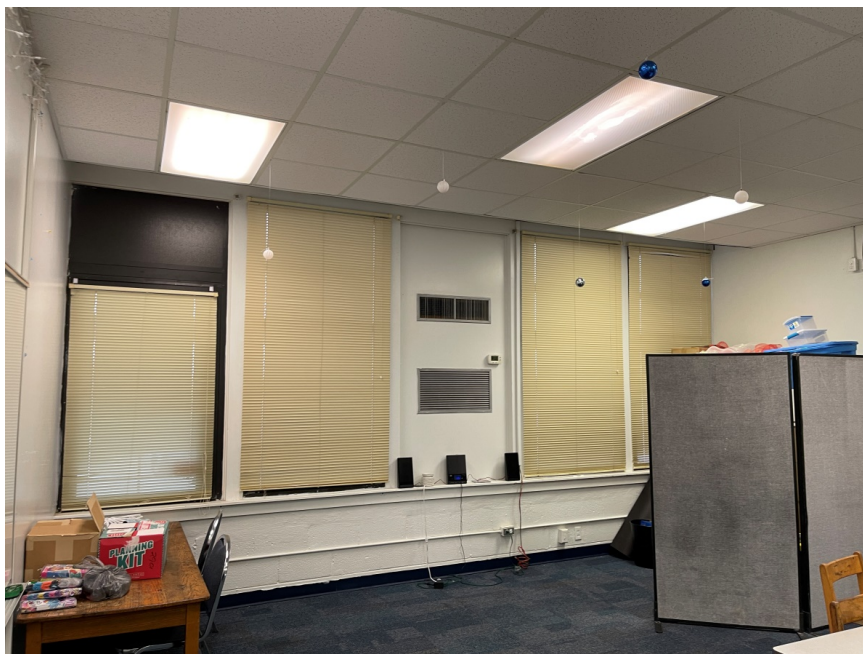
Building 2 - Inside view of the wall mount package unit

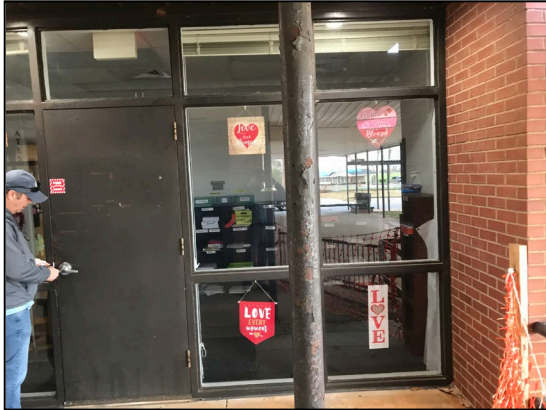
Building 10 Entry

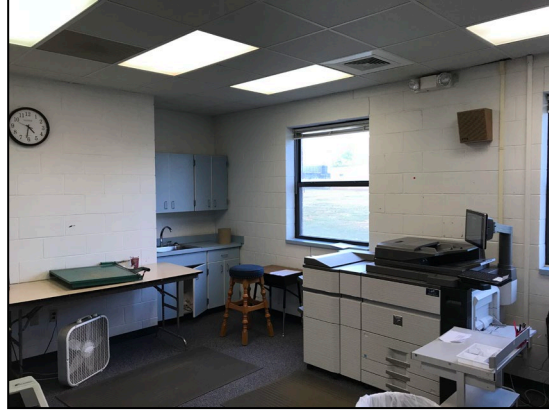
Building 10 Office

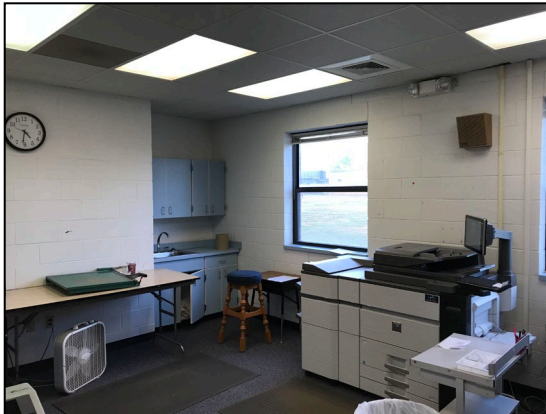
Work room

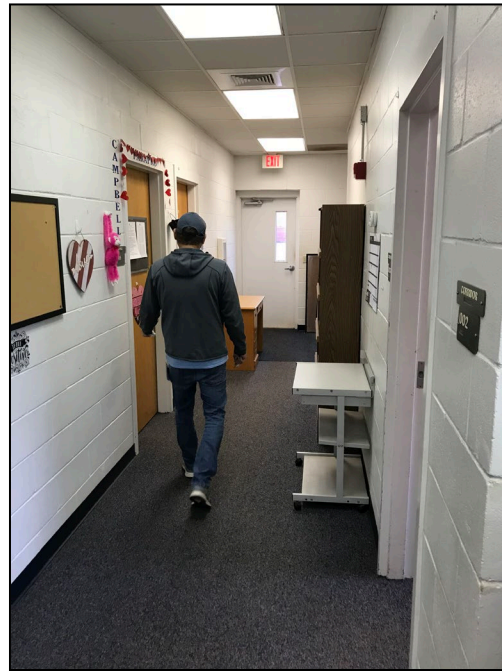
Interior Corridor

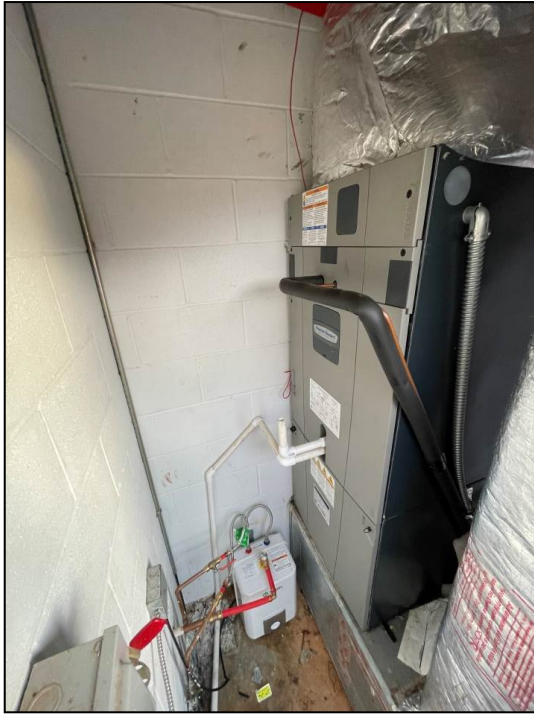
Building 10 - Existing split system DX and water heater inside mechanical room

1. Replace HVAC system serving this building with high efficiency unit. Provide building DDC (Direct Digital Controls) system with new code compliant system(s). System would need to be provided with modern BACNet architecture as part of any upgrade. Web based energy management software permits oversight of component status but provides limited to no ability to change set point or schedule operation.
2. Replace ductwork system with exterior insulated metal ductwork.
3. The new system(s) will supply all spaces with the proper dehumidified outside air based on ASHRAE 62.1 standard.
4. All exhaust systems would be replaced and comply with current standard practices. A comprehensive review of the new systems would be performed in order to verify compliance with the 2020 FBC Energy Conservation Code.
5. Estimated repair cost = **\$63,000**

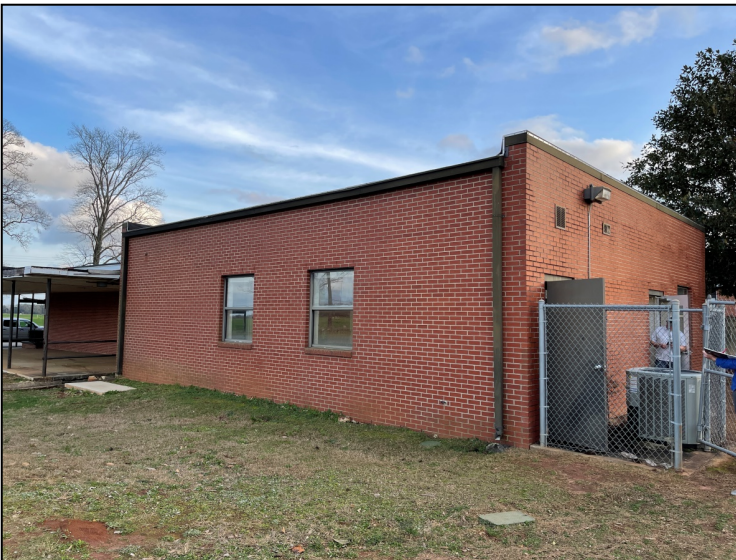
Building 10 - Exterior condensing unit, outside air louver and single pane windows

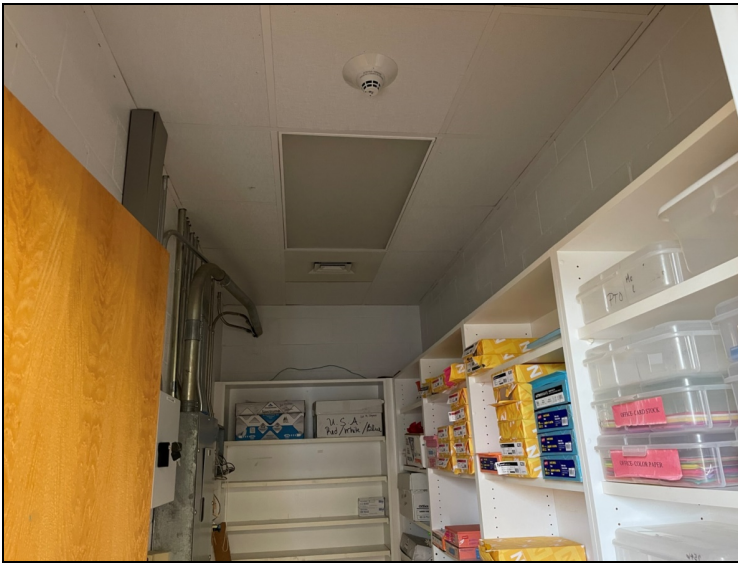
Building 10 - Electrical room mixed with storage room (not code compliant).
Room also equipped with heat detector

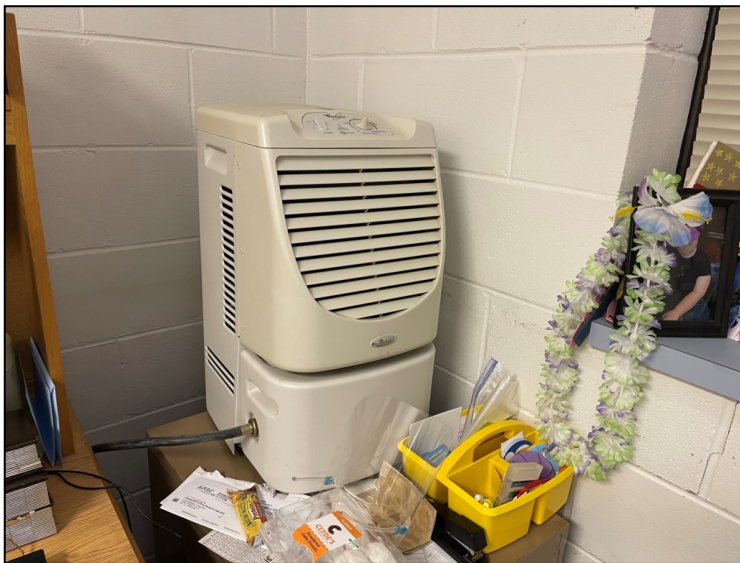
Building 10 - Dehumidifier in one of the offices

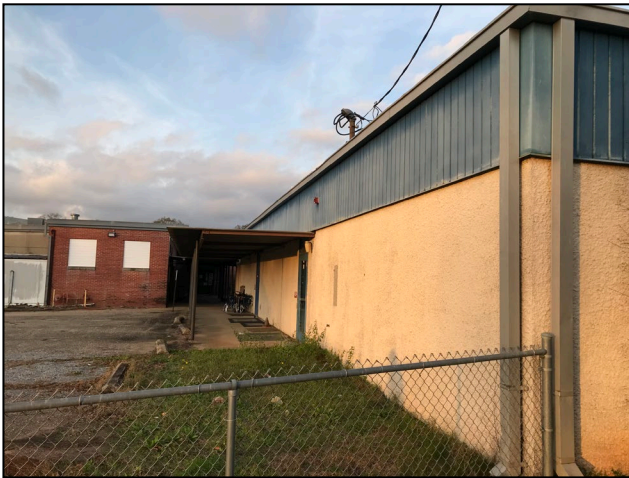
South Side Elevation

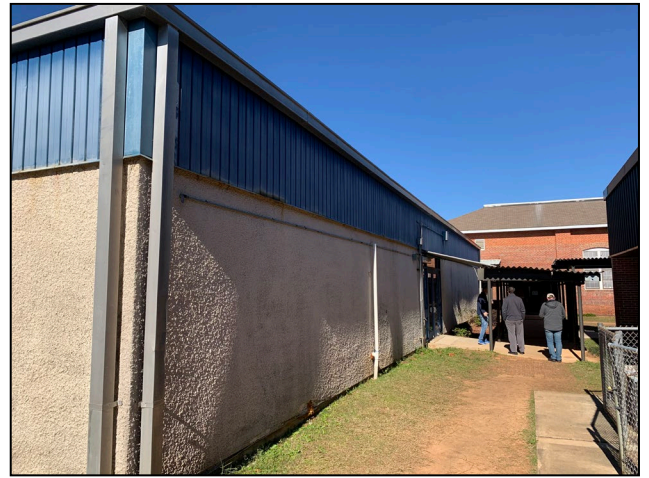
North Side Elevation

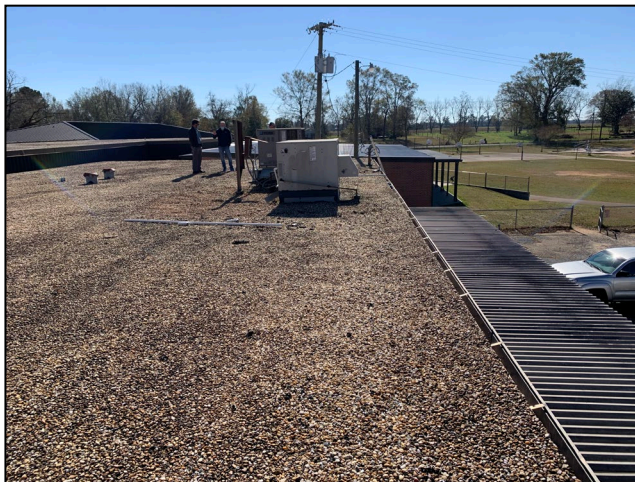
Rooftop condition

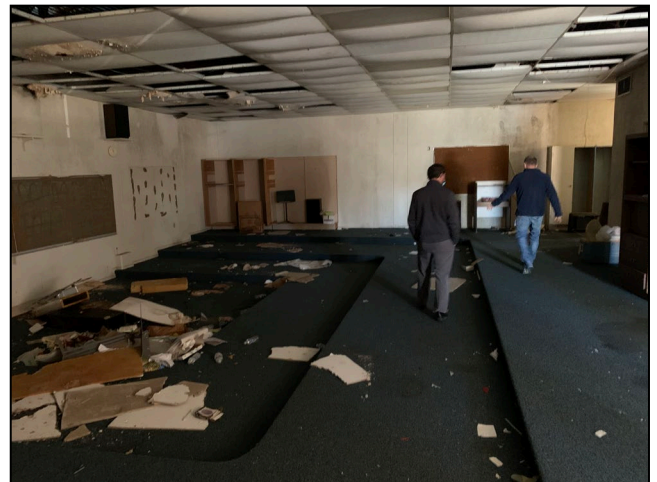
Tiered flooring

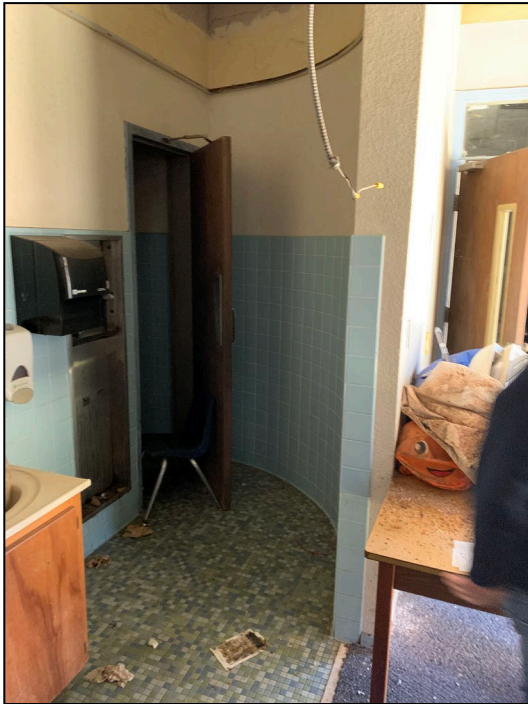
Restroom Entry

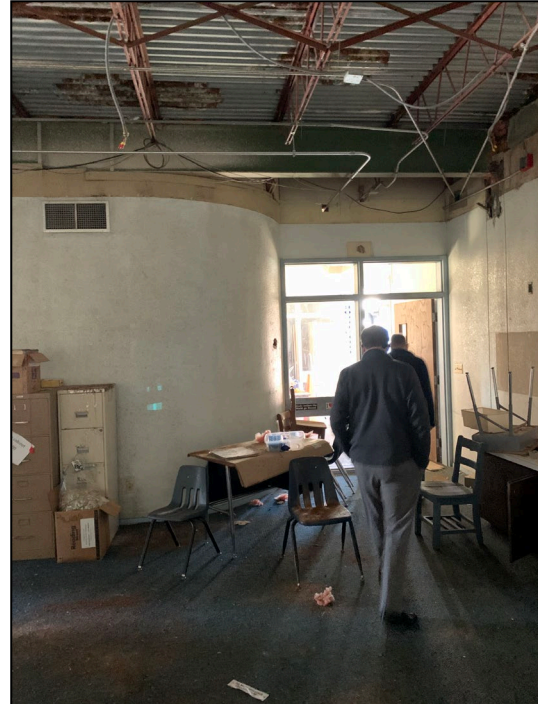
Interior condition

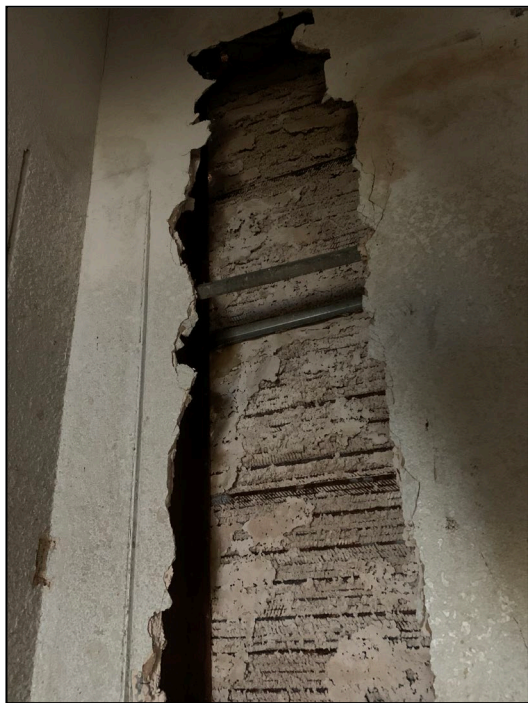
Exterior wall condition

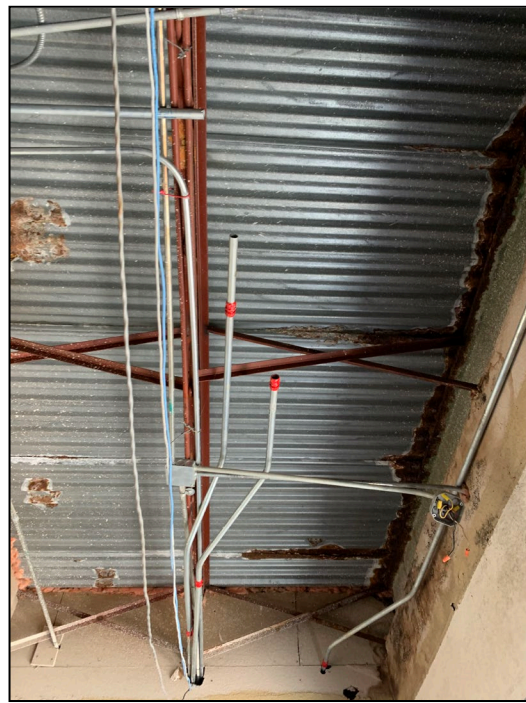
Roof deck condition

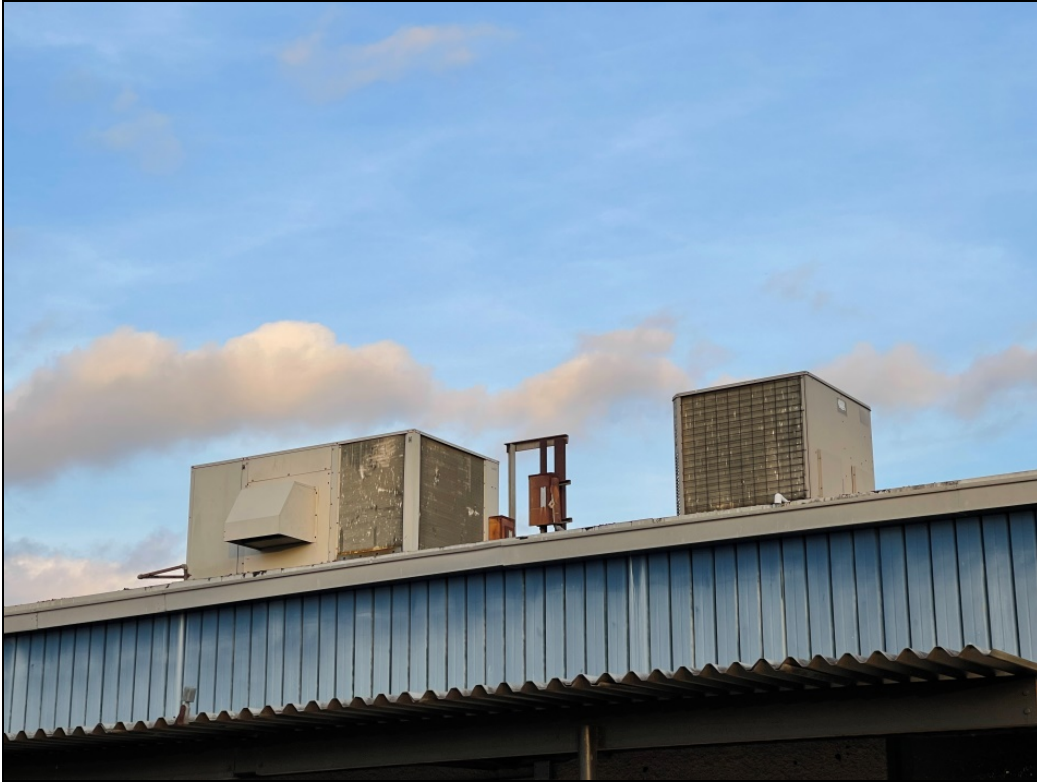
Building 15 – Rooftop Unit

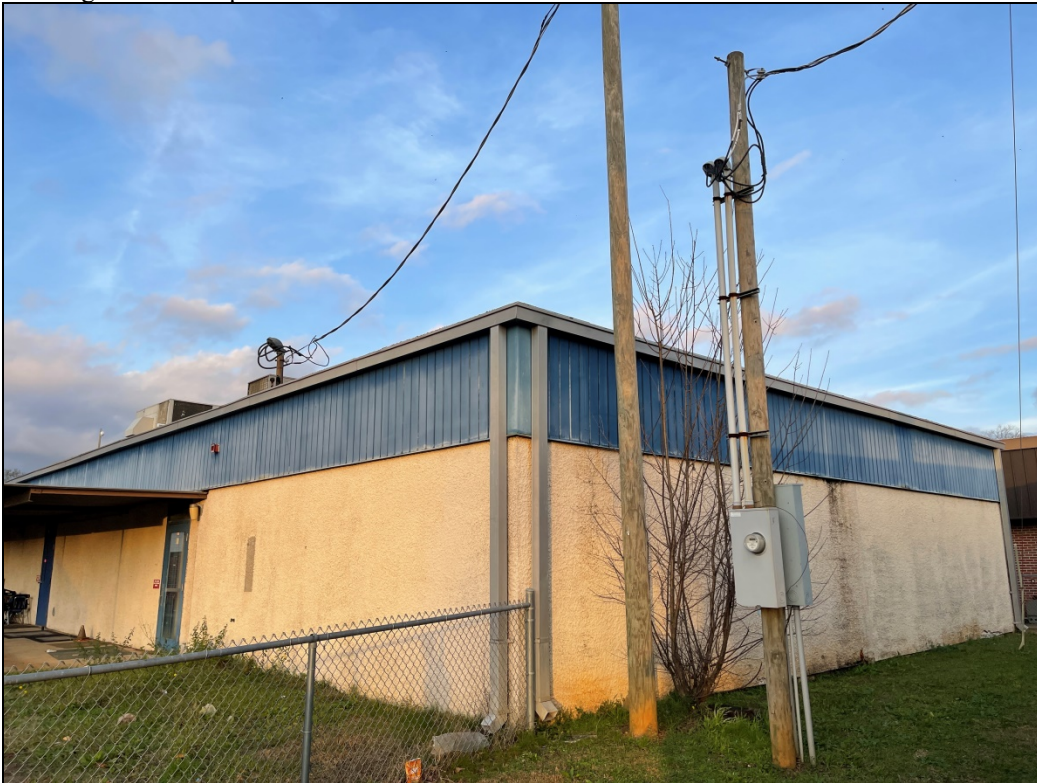
Building 15 – Exterior view with electrical connection and HVAC unit equipment

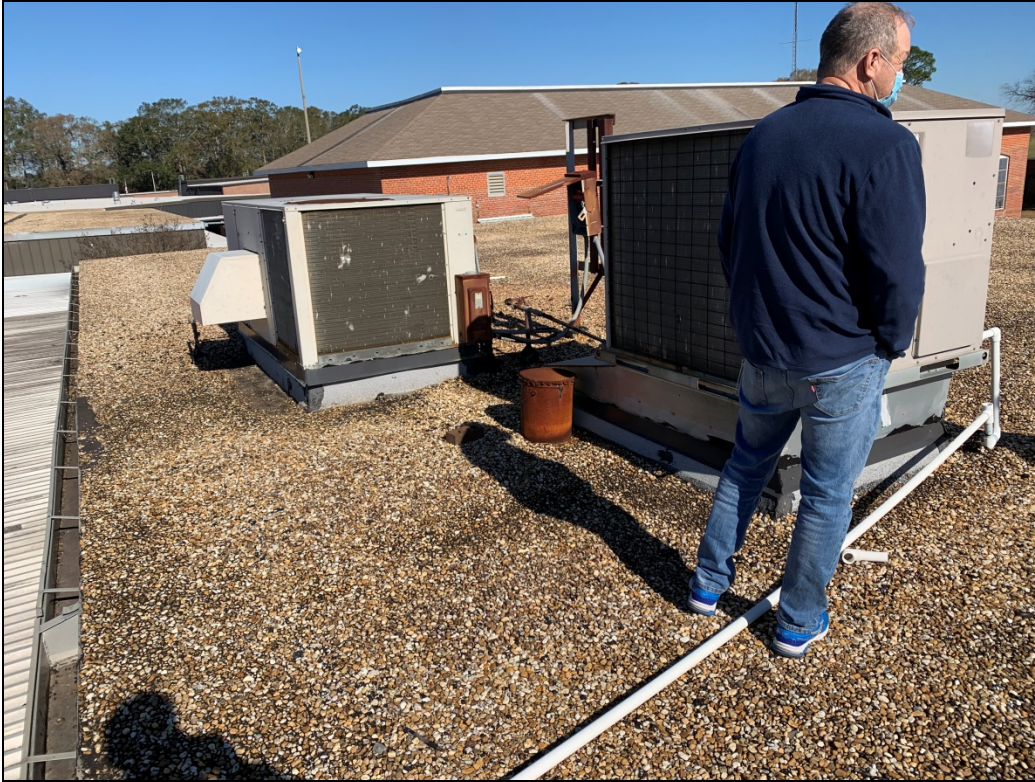
Building 15 – HVAC equipment condition

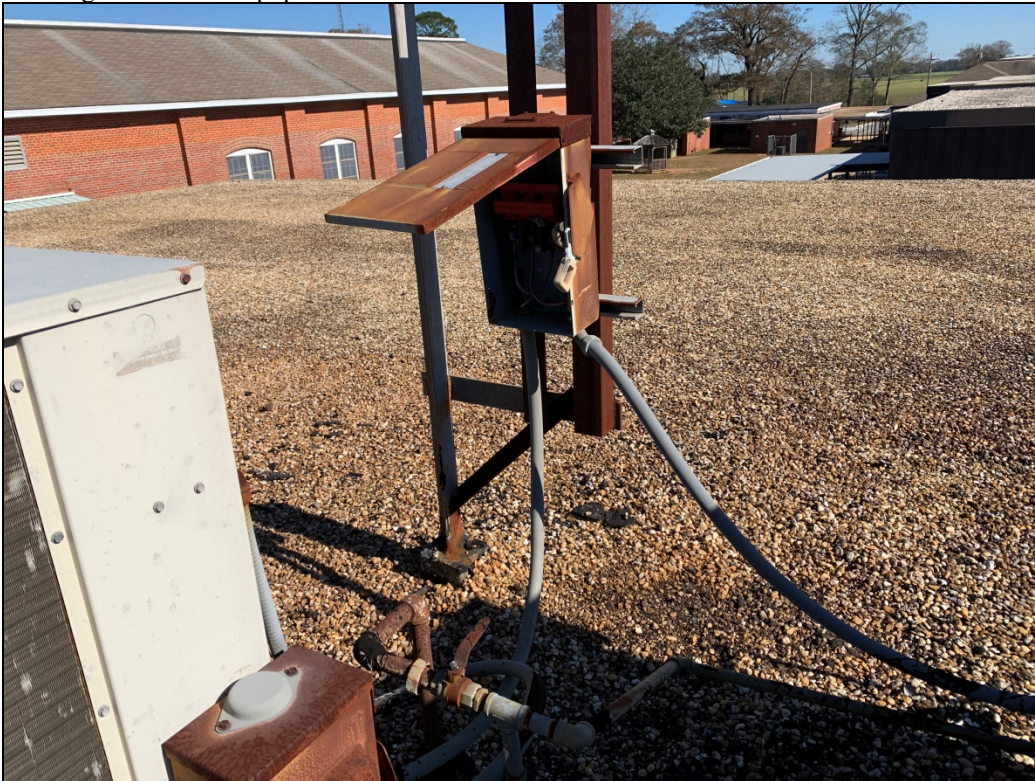
Building 15 – HVAC equipment disconnect condition

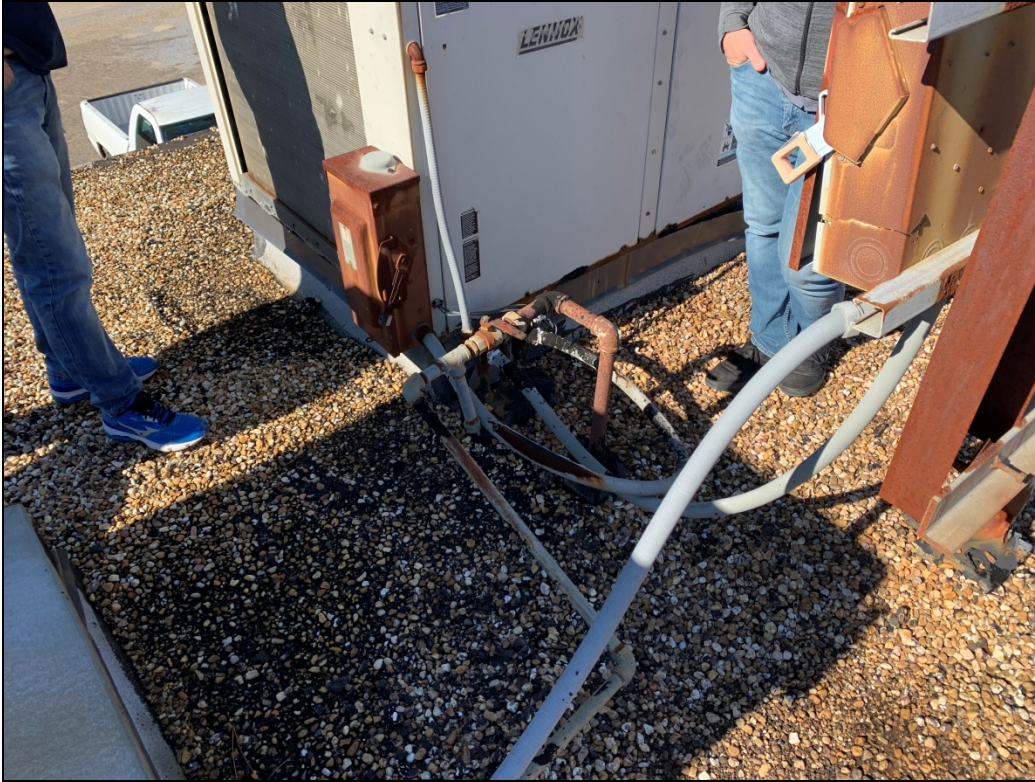
Building 15 – HVAC equipment condition

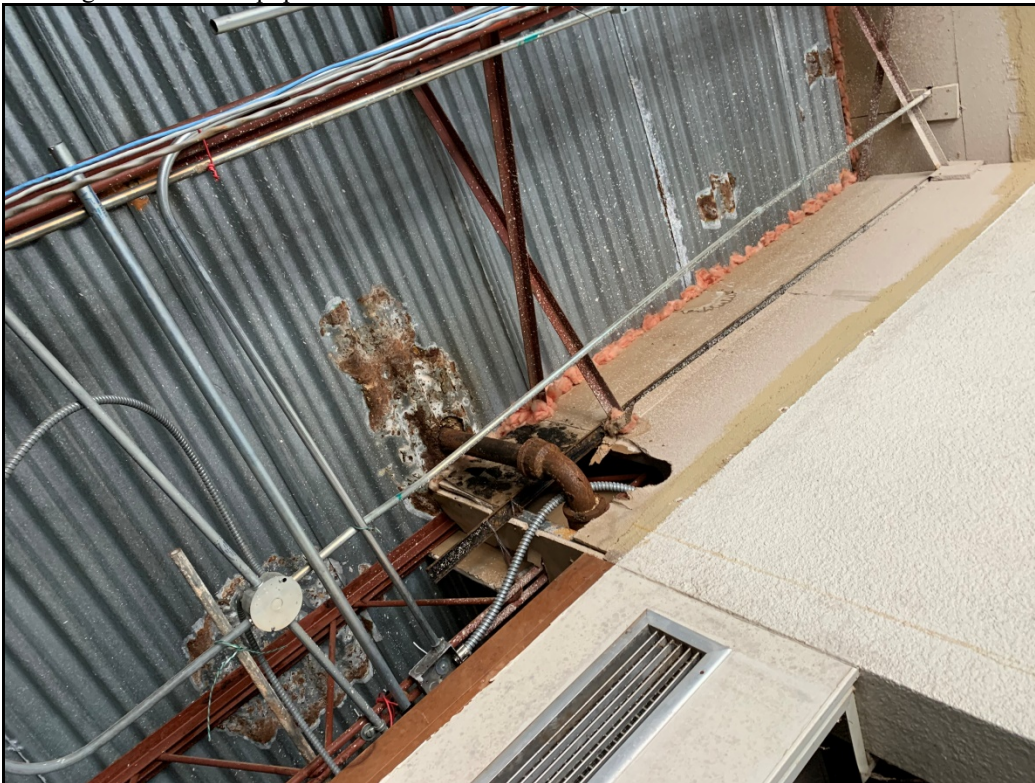
Building 15 – Current roof penetration condition with rusted pipe and structure

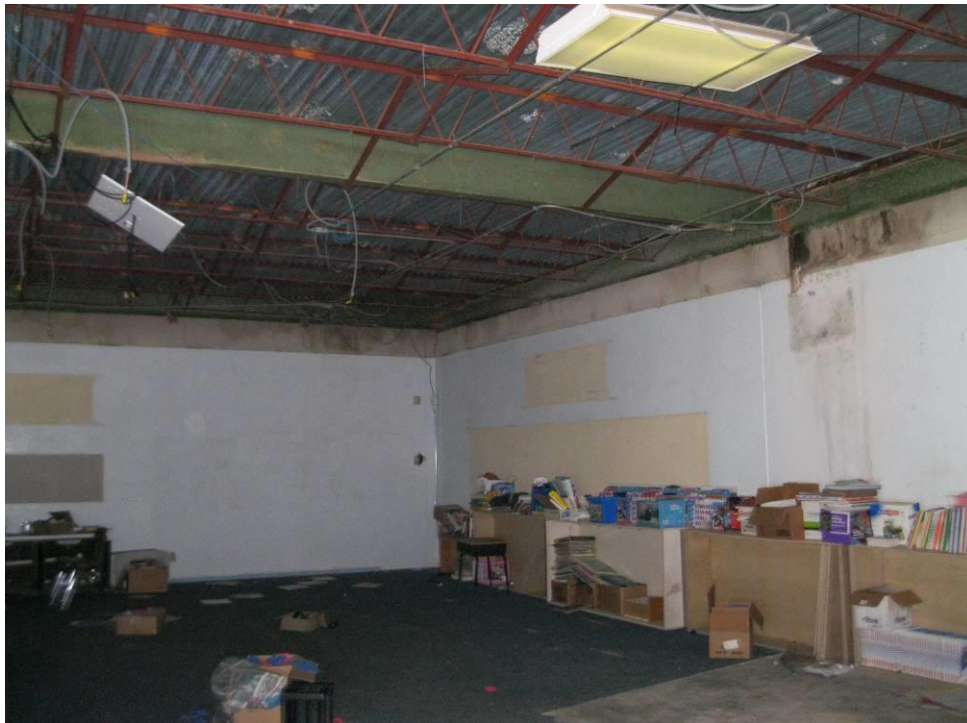
Building conditions were found as described. Photo 1 above is an overall perspective of conditions observed from inside. The building has obviously been vacant for a significant duration and mold was noted throughout. Photos 1 above and 2 and 3 below show the mold conditions from a distance and closer up respectively.

The hazardous conditions of this building lead us to the conclusion that it should no longer be considered for occupancy without remediation. Major structural repairs and enhancements are needed if this building is intended to be remediated and restored to service as a school facility. In order to properly assess and repair the structure, the roofing and wall finishes inside and out will need to be removed. It is likely that the roof deck would have to be removed entirely and replaced after repairs are made to the steel roof framing. Severely damaged steel roof joists ends will require rebuilding after removing the deteriorated steel. The main support steel beams and columns appear to have surface rust that will need as a minimum cleaning and recoating. Further, additional structural framing will be necessary to update the wind force resisting system to current code requirements if the building is brought back to service. We would anticipate new lateral load resisting structural steel bracing or shear walls at the perimeter on all four sides.

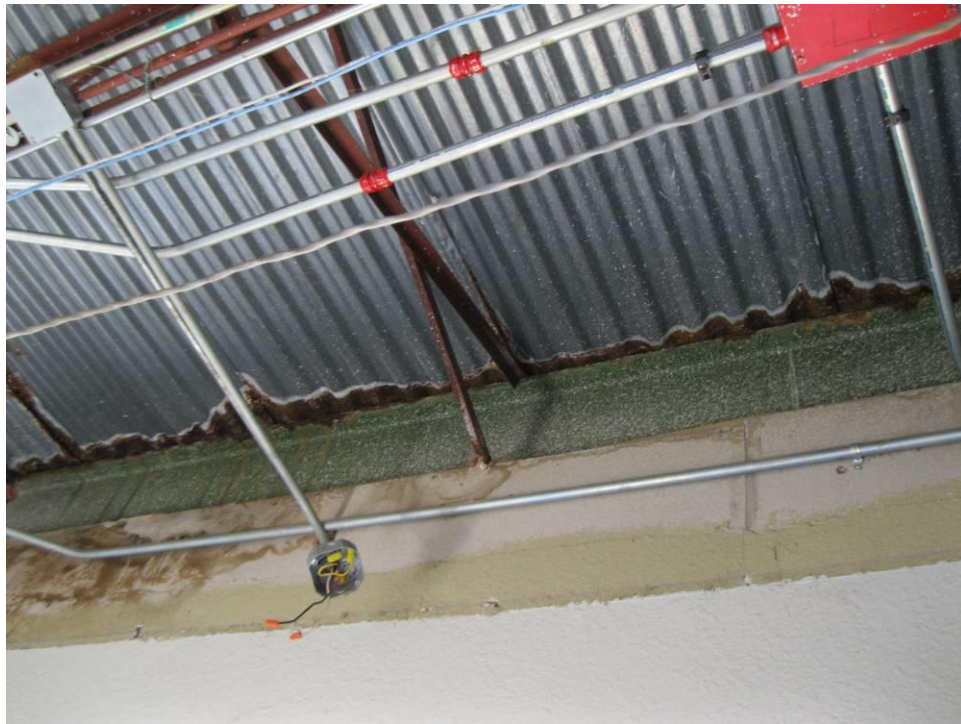
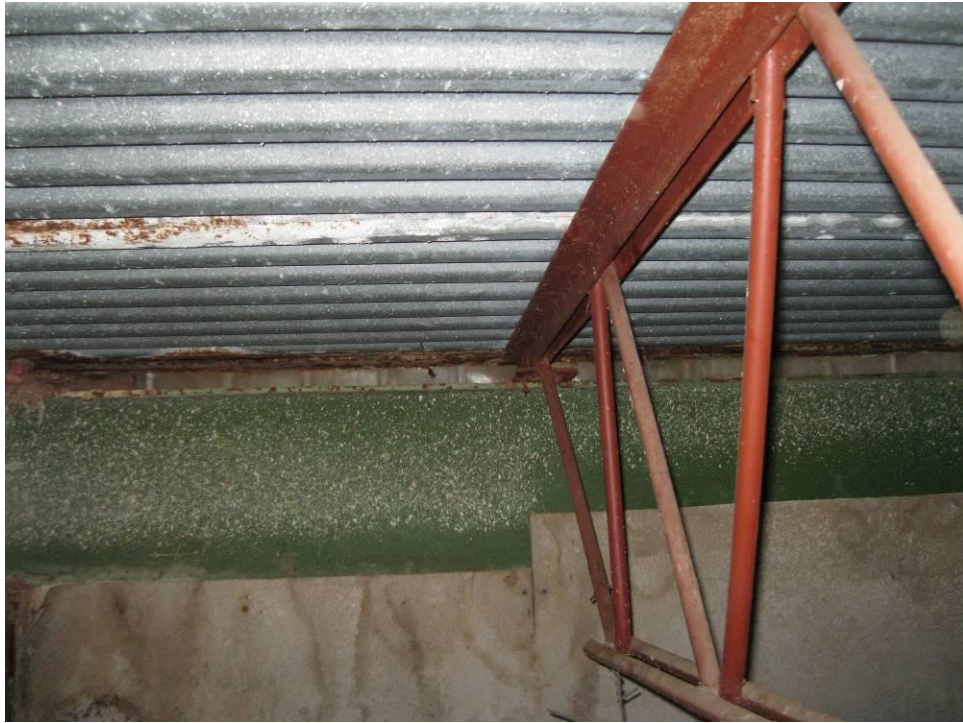
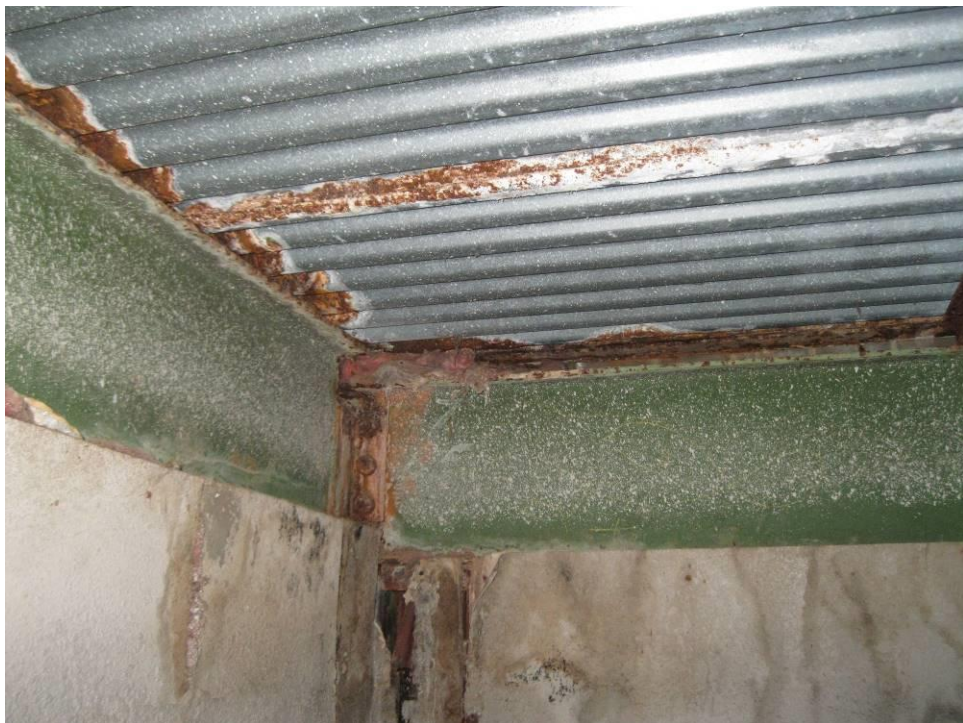
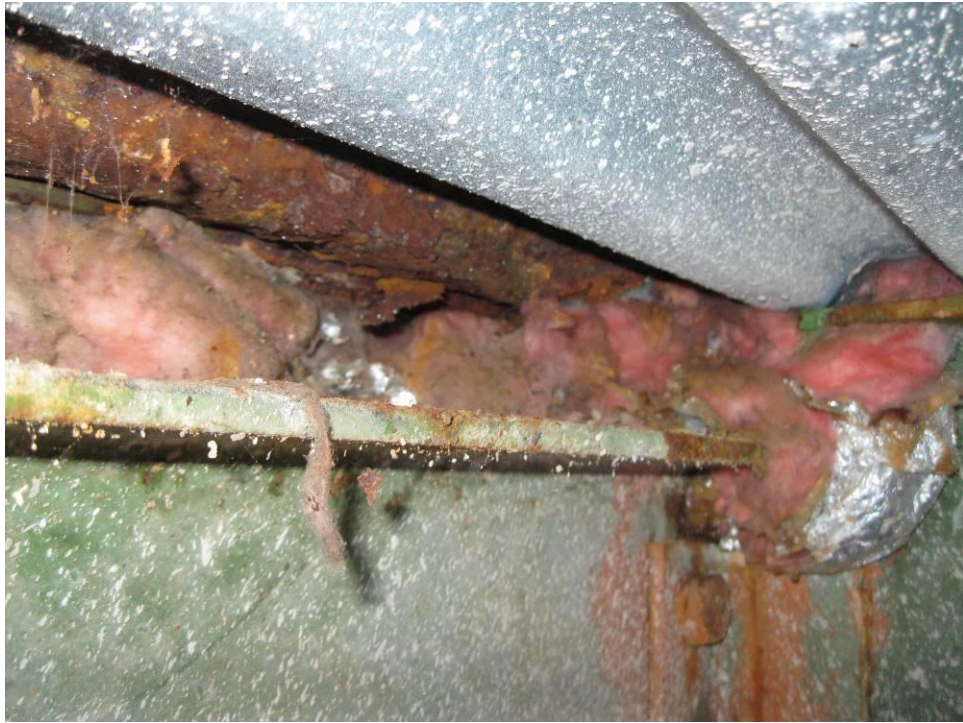
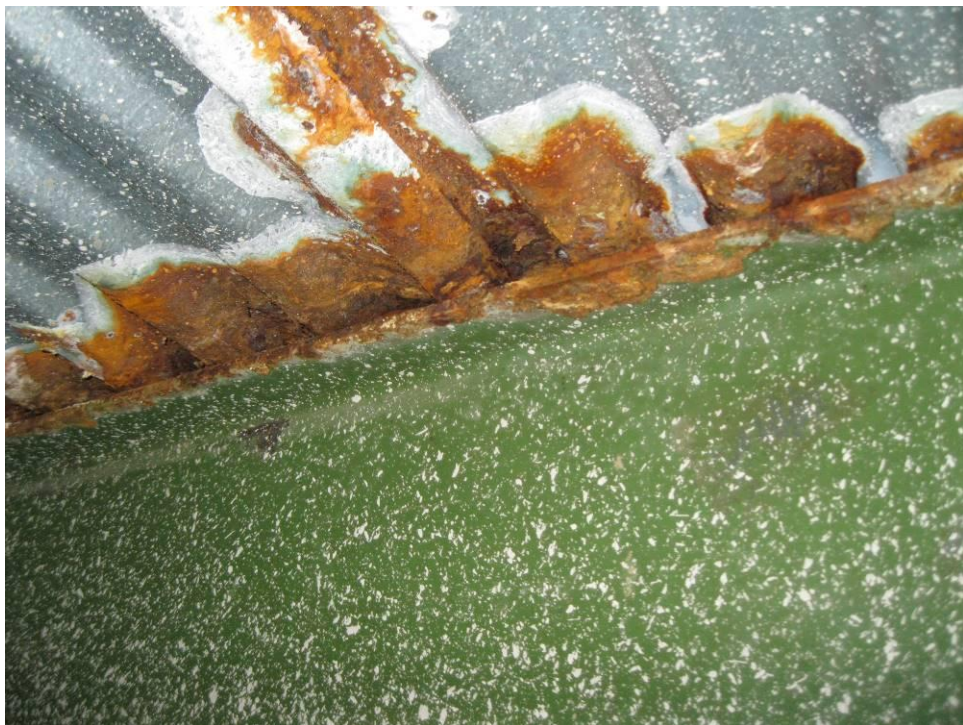
In addition to mold complications, the structural roof deck and steel joist framing is in bad shape from the ongoing roof leaks. The roof deck appears from inside to be one inch deep metal form deck in lieu of a deeper metal roof deck profile. This type of deck is usually installed with lightweight insulating fill roofing material and is typically a thinner gage than a metal roof deck profile. All around the building perimeter, this form deck has rusted from exposure to moisture. The deck is rusted through completely in many places. Due to this deterioration, the deck and weld attachments capacities to support roof diaphragm loads to the lateral load resisting structural system are diminished. The diaphragm perimeter is critical to the building's overall structural stability when exposed to hurricane force wind loads. The following Photos 4 through 8 demonstrate the severity of the roof deck boundary conditions observed.

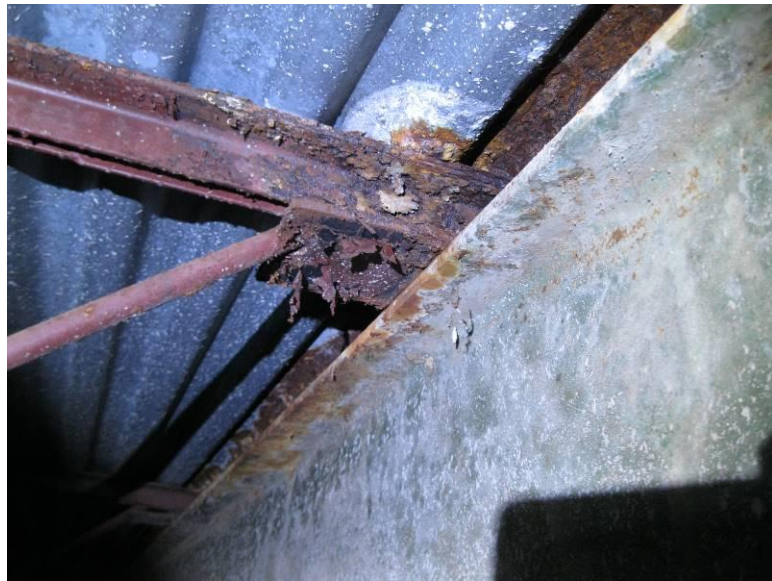
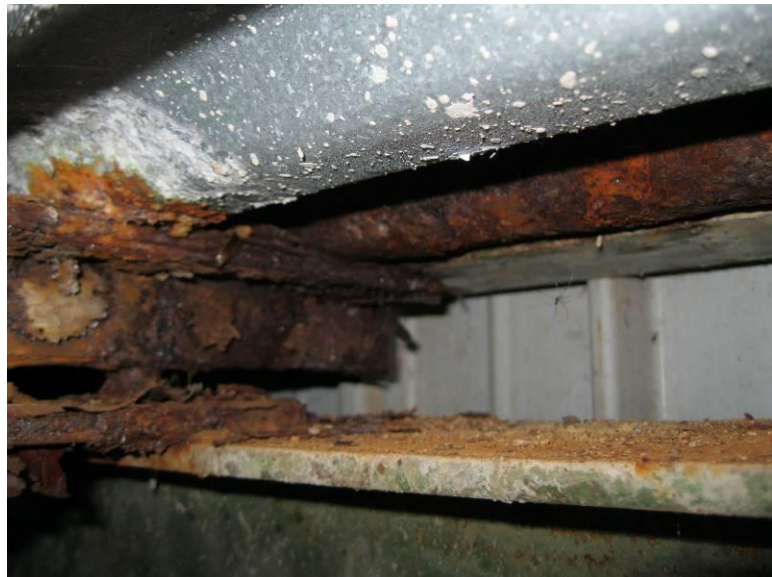
Corrosion of the joist framing is also severe in many locations. As described above concerning the roof deck, the steel roof joists are rusting around the building's perimeter at their end bearings. Most of the joists ends have some degree of deterioration. Critical conditions have already seen failures from the loss of steel section in the bearing end. The most severe joist end condition is shown in Photos 9 and 10 below. Steel with this degree of deterioration will not support the design loads. The joist end in Photo 10 is showing signs of failure as indicated by the apparent displacement.

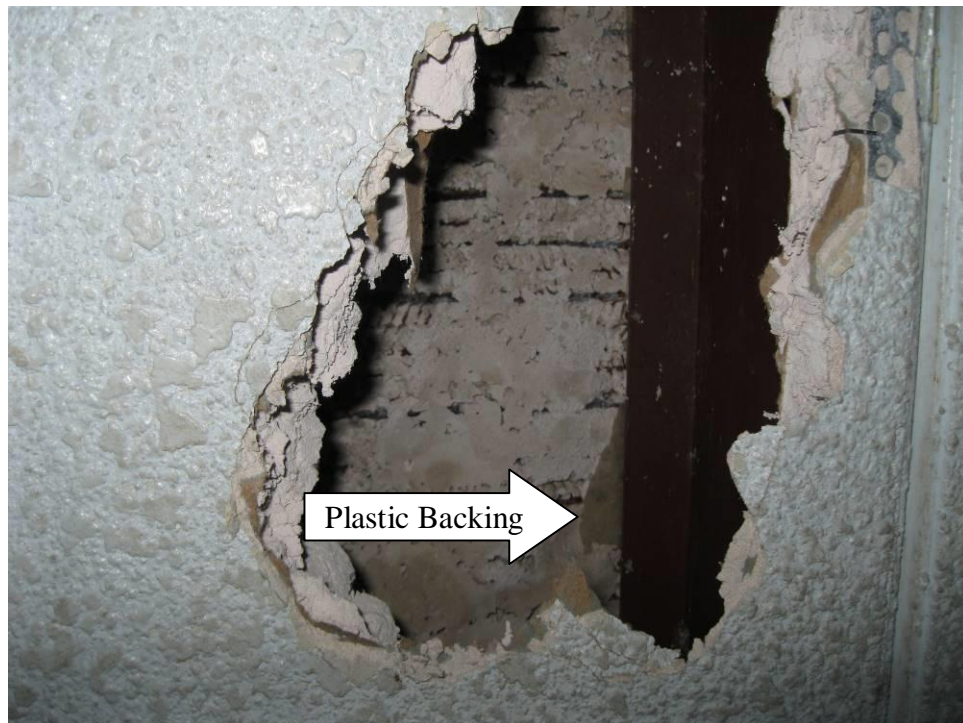
Breaches in the perimeter walls were observed as well. The outside wall finish is hard coat stucco over metal lath fastened to metal stud framing with a plastic backing. The plastic was noted to be brittle and compromised where the backside of the stucco was visible. Photo 11 below shows a condition where we punched through the drywall to observe the wall cavity. Noted is a small piece of the plastic that remains. Plastic was observed in tact behind the stucco in other locations where the wall cavity was more accessible. Although intact, the plastic was brittle and would break apart when touched. We believe that the stucco was intended to be the water barrier and the plastic is a backup moisture barrier.
