Jay Elementary School

BUILDINGS 2, 10 AND 15
EXISTING CONDITIONS AND CASTALDI STUDIES

FEBRUARY 26, 2021

Santa Rosa County District Schools

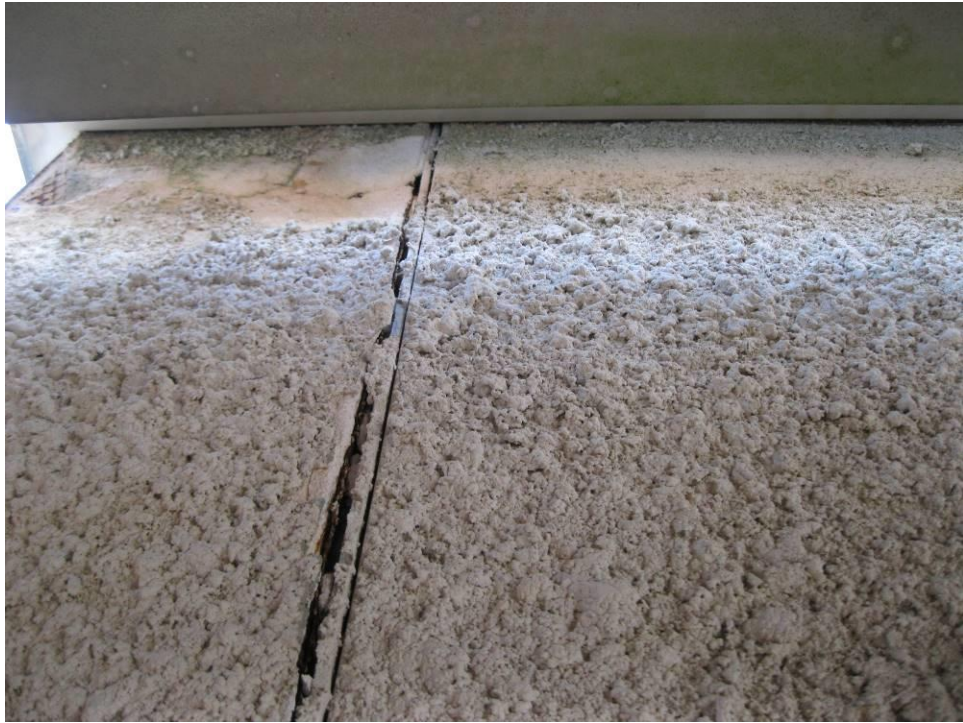
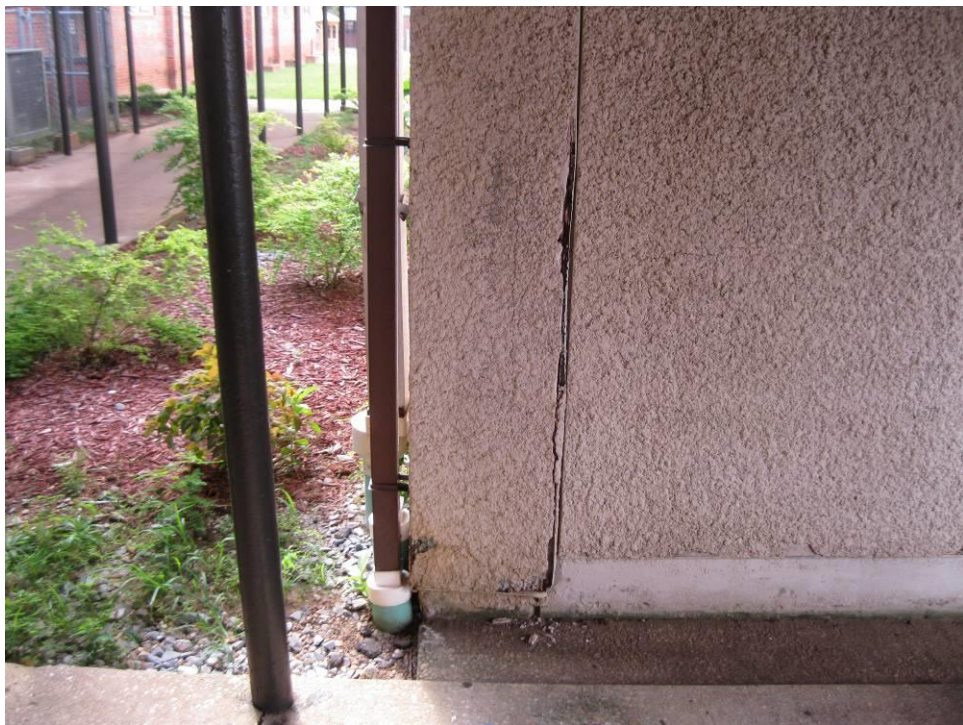
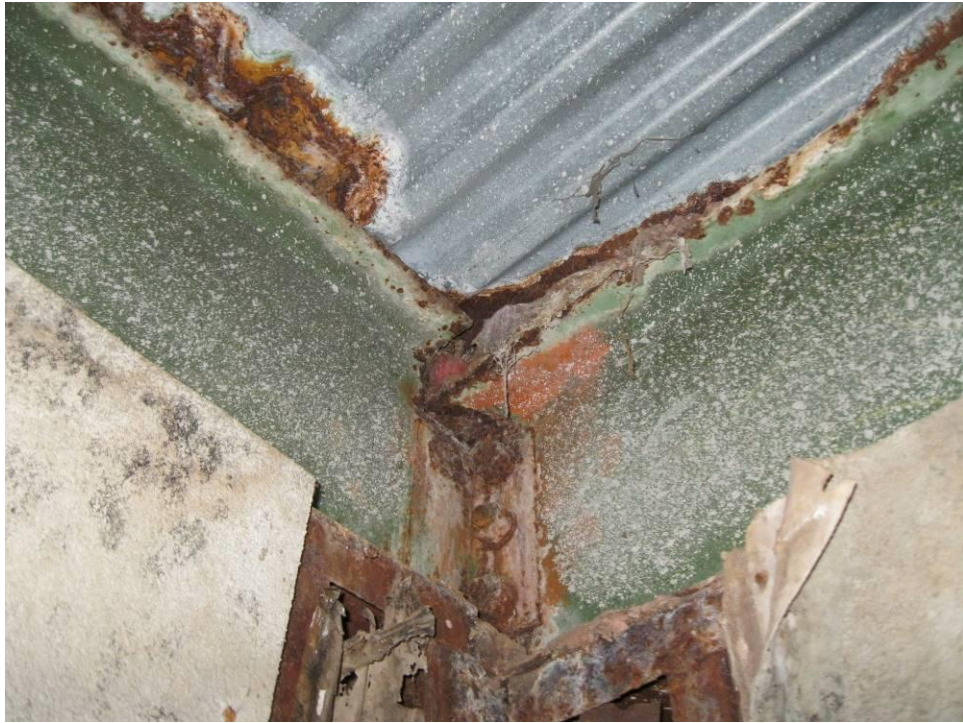
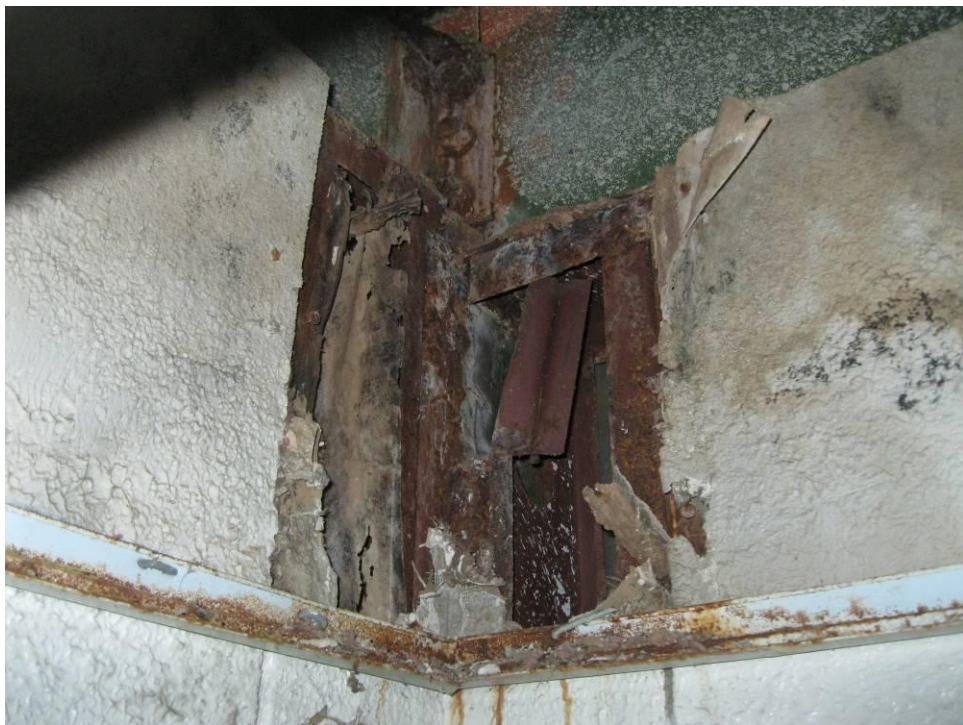
Obvious wall and roof leaks were observed at the building's northwest corner where the exterior stucco wall finish has opened up along a vertical joint. This condition is shown from outside in Photos 12 and 13 below. Photos 14 and 15 following show the inside view of this same building corner. We did not remove the inside drywall finish below ceiling level but water damage was noted from the floor to roof.

The hazardous conditions of this building lead us to the conclusion that it should no longer be considered for occupancy without remediation. Major structural repairs and enhancements are needed if this building is intended to be remediated and restored to service as a school facility. In order to properly assess and repair the structure, the roofing and wall finishes inside and out will need to be removed. It is likely that the roof deck would have to be removed entirely and replaced after repairs are made to the steel roof framing. Severely damaged steel roof joists ends will require rebuilding after removing the deteriorated steel. The main support steel beams and columns appear to have surface rust that will need as a minimum cleaning and recoating. Further, additional structural framing will be necessary to update the wind force resisting system to current code requirements if the building is brought back to service. We would anticipate new lateral load resisting structural steel bracing or shear walls at the perimeter on all four sides.
