## Gulf Breeze Middle School

BUILDINGS 2

EXISTING CONDITIONS AND CASTALDI STUDIES

MAY 2021

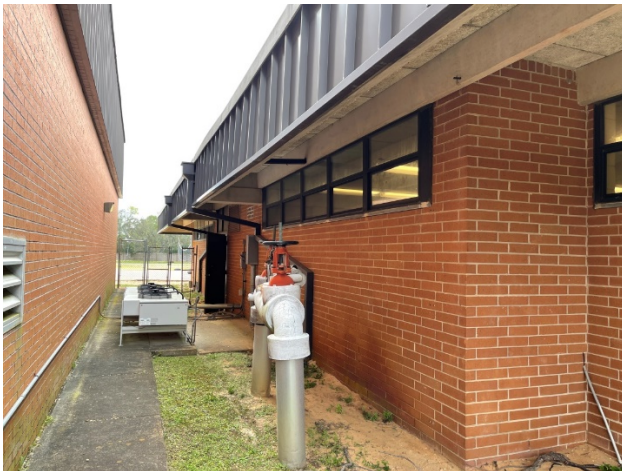
**Building 2 – Exterior view with backflow preventer (to remain) and HVAC unit equipment**

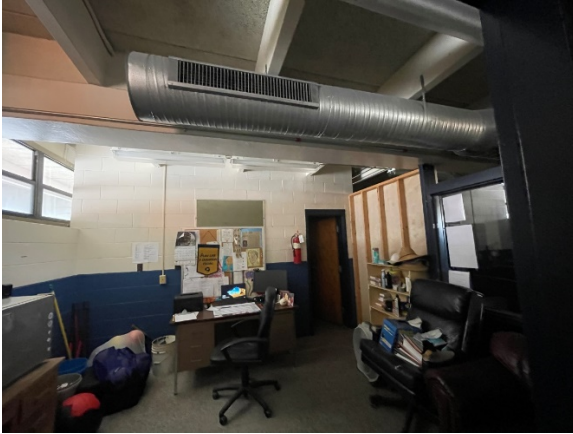
**Building 2 – Exposed supply ductwork inside coach's office.**

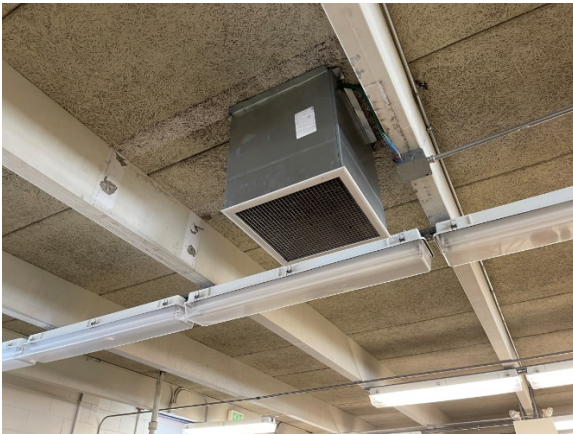
**Building 2 – Typical exhaust duct and grille inlet with roof mounted fan.**

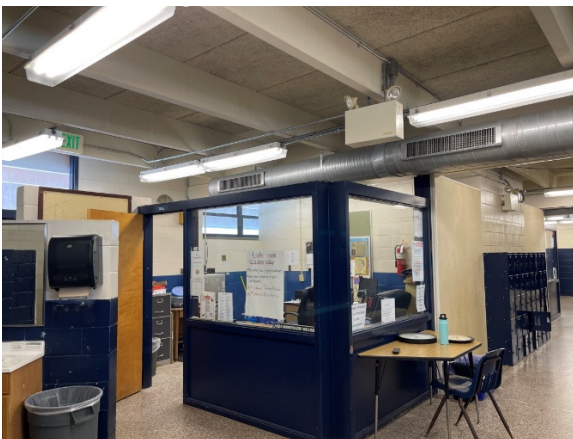
**Building 2 – Typical exposed supply ductwork and grille serving the locker rooms**

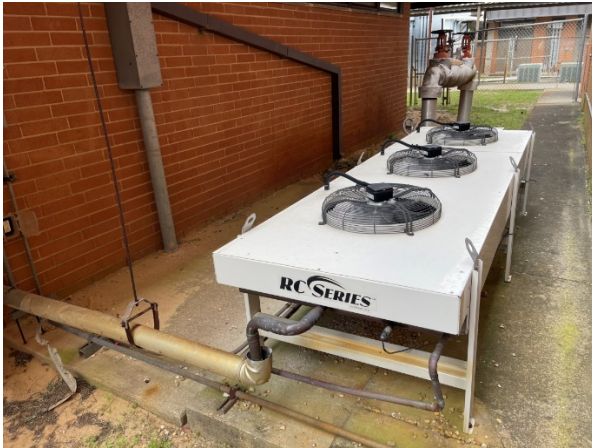
The existing systems are functioning but are well beyond their useful service life. Typical median life of DX packaged equipment is about 15 years. It appears that these existing units are up to current codes for ventilation, service, and safety standards however there is no means to condition the building when the outside air unit is OFF. Therefore, the building uses lots of energy during unoccupied mode. In order to bring the HVAC system up to current codes and standards, the following needs to be performed:

**Building 2 – Split system condensing unit well past useful life.**

1. Replace HVAC system serving this building completely with high-efficiency units that incorporates energy recovery unit and ductless split system. The ductless split units will condition the building during unoccupied times. The energy recovery unit will use the exhausted conditioned air to pre-condition the outside air. This will save some energy cost.

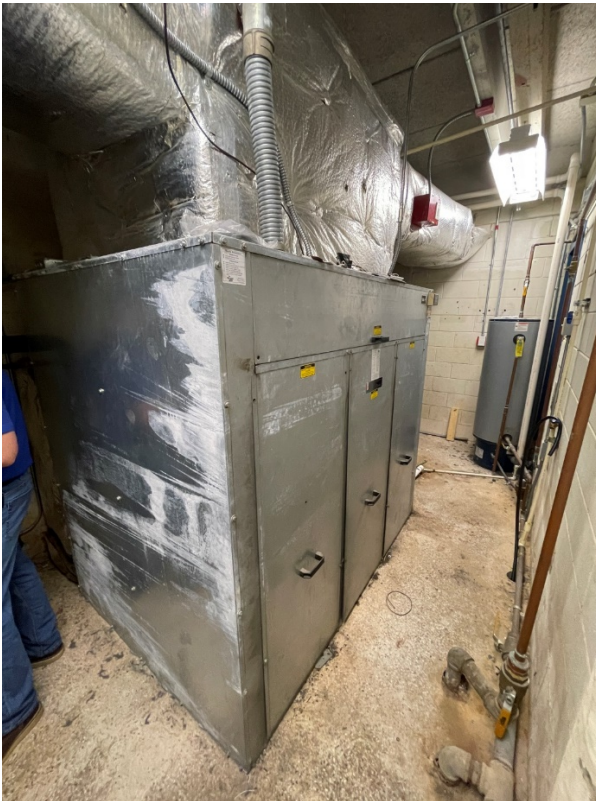
**Building 2 – Split system DX outside air unit well past useful life.**

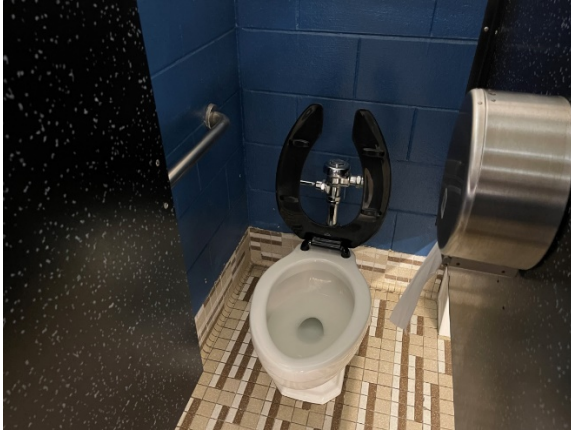
**Building 3 – Non-ADA compliant water closet stall**

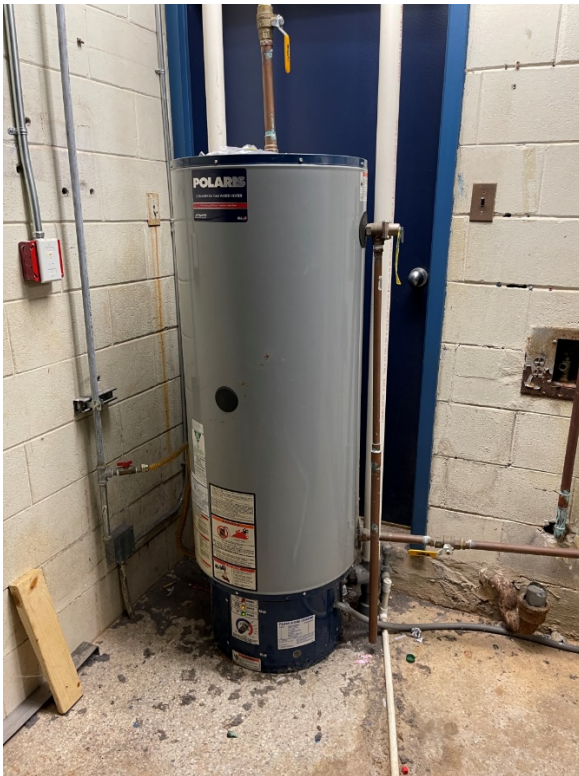
Plumbing fixtures are old and need to be replaced. Most of the remaining fixtures should be replaced based on their useful life. There is plumbing infrastructure within the building that appears original to the construction of the building. The building is served by a gas fired water heater located inside the mechanical room. The Median Service Life of a gas fired water heater is approximately 13 years. As water heaters age, their efficiency decreases. The majority of the visible hot water piping was not insulated, which is a loss of energy and does not meet the current Florida Energy requirements. The water heater is not piped properly since there is no mixing valve.

**Building 2 – Existing gas fired water heater without mixing valve and insulation.**

1. Replace all the plumbing fixtures and infrastructure piping. Provide new accessories, toilets, sinks, urinals, showers, faucets and for the new fixtures.
2. Provide existing water heater with new mixing valve to prevent legionella growth inside the tank.
3. Coordinate and review the Florida Building Code for the addition of more fixtures to meet the occupant count.
4. Estimated repair cost = **\$18,000**

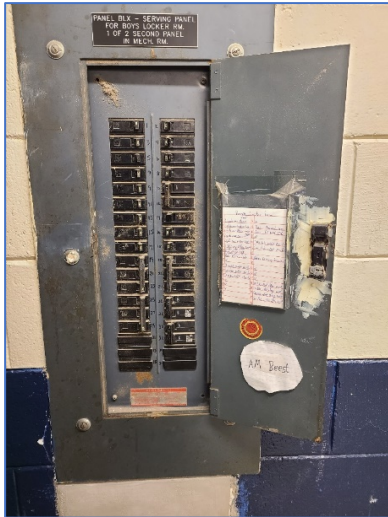
Building 2 has two electrical services. Service one is 208Y/120 volt, 100-amp panel BLX – formerly panel LP-PE – fed from the campus main panel MPA. Service two is 208Y/120 volt, 400-amp panel NBP. The source of panel NBP was not evident during the survey. Panel BLX is at the end of its usable life and should be demolished in any future renovation. Panel NBP is in fair condition and would not require replacement in any immediate renovation. It is recommended to convert this building from two services to one. Existing loads, demolished loads, and added loads should be considered to determine the proper size for a single service to the building.

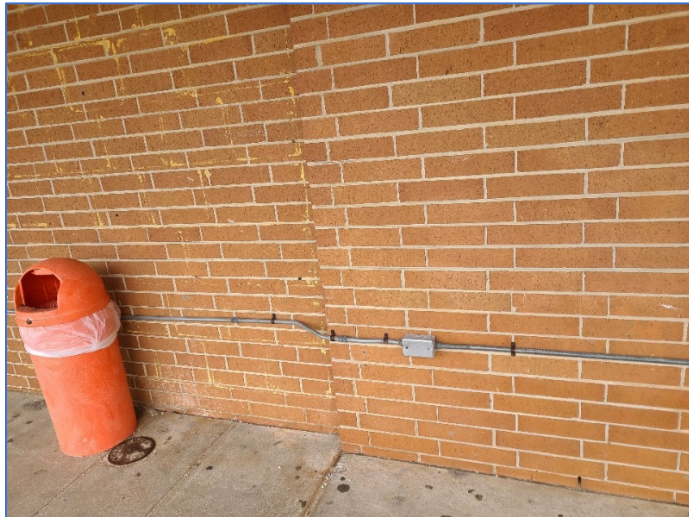
Surface raceway

The electrical systems throughout the facility utilize surface raceways. It is recommended that all raceways be concealed during any future renovations.

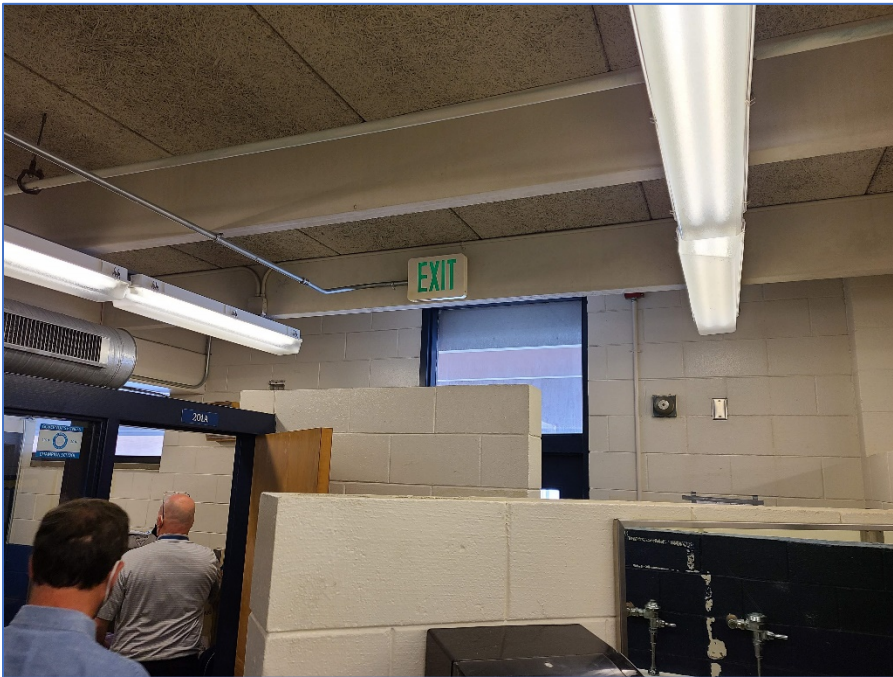
**Lighting Fixtures**

The existing light fixtures are inefficient, fluorescent type. The light fixtures show signs of age with rust, moisture damage, and physical damage. It is recommended to upgrade all light fixtures in any future renovations. Lighting controls are not code compliant with proper occupancy and vacancy detection. Lighting controls will be required to be upgraded in any future renovation.
