## Rhodes Elementary School

BUILDINGS 10  
EXISTING CONDITIONS AND CASTALDI STUDY

JUNE 2021

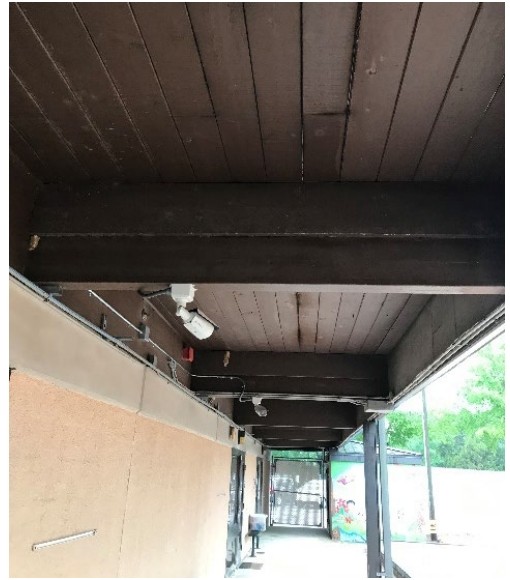
**Covered walk**

The site has some access from the open area on the south side. The side is served by a covered walk. The cover on this walk is built up roofing over wood decking with wooden beams and joists. The walk appears to be in decent shape but needs some painting and other maintenance.

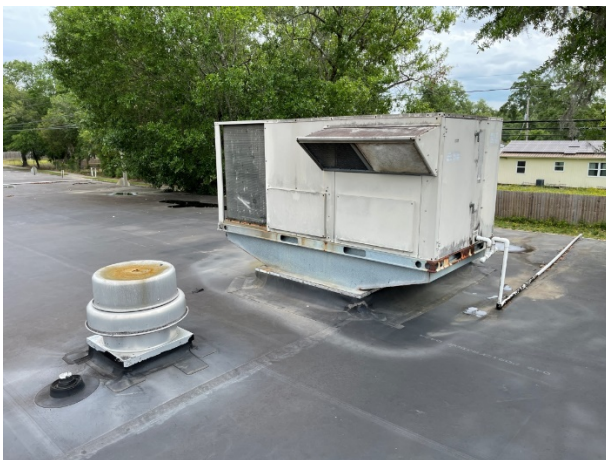
The existing systems are functioning but are well beyond their useful service life. Typical median life of DX packaged equipment is about 15 years. It appears that these existing units are not up to current codes for ventilation, service, and safety standards. In order to bring the HVAC system up to current codes and standards, the following needs to be performed:

Building 10 – Rooftop unit and exhaust fan

1. Replace HVAC system serving this building with highly efficient units with hot gas reheats for active dehumidification sequence.
2. Provide building DDC (Direct Digital Controls) system with new code compliant system(s). System would need to be provided with modern BACNet architecture as part of any upgrade. Web based energy management software permits oversight of component status but provides limited to no ability to change set point or schedule operation.

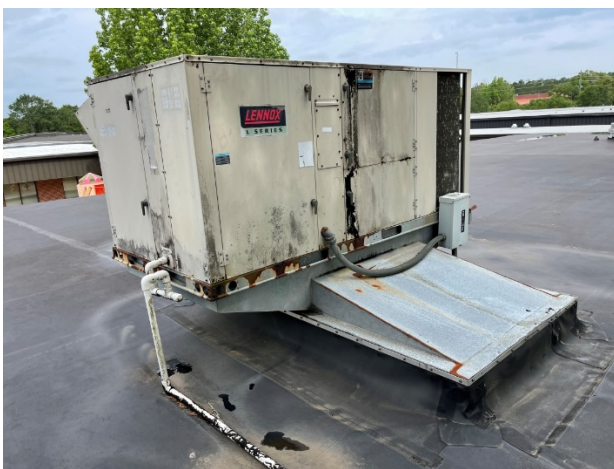
Building 10 – Rooftop unit

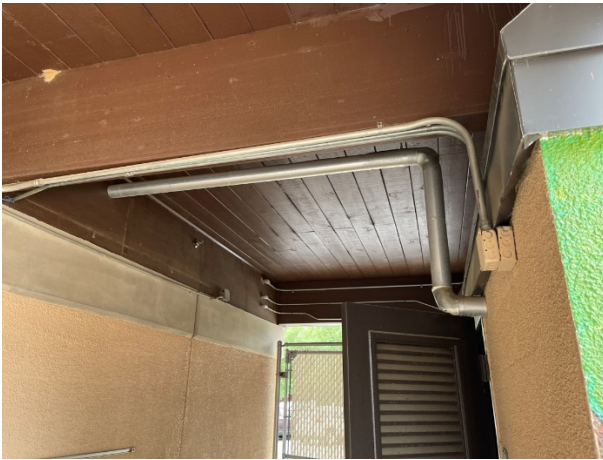
The building is currently sprinklered. There is no major improvement needed apart from cosmetic modification.

Building 10 – Exposed sprinkler piping from sprinkler room

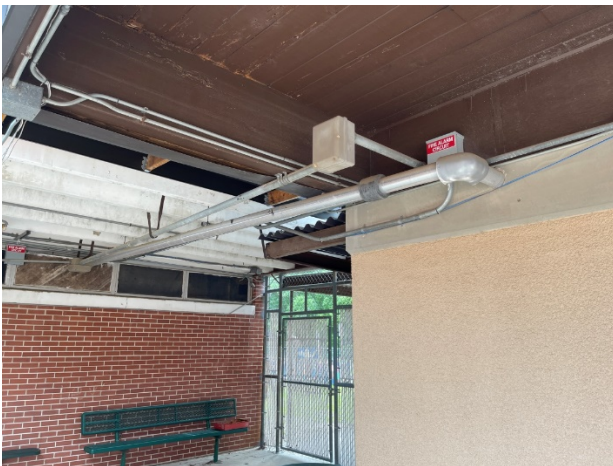
Building 10 – Exposed sprinkler piping from Building 10 to another building

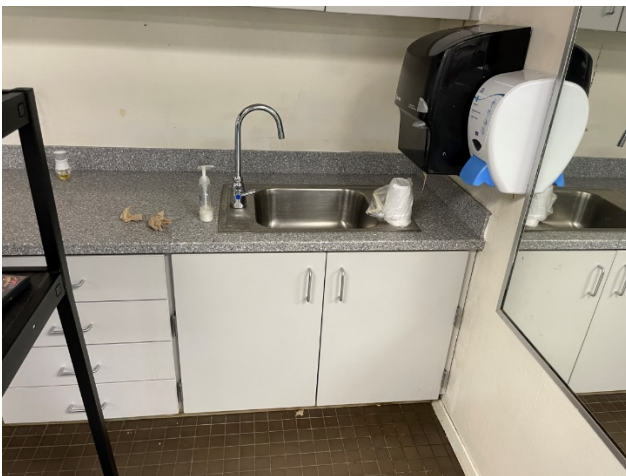
Plumbing fixtures are old and need to be replaced. Most of the remaining fixtures should be replaced based on their useful life. There is plumbing infrastructure within the building that appears original to the construction of the building.

Plumbing fixture

1. Replace all the plumbing fixtures and portion of the piping. Provide new accessories, toilets, sinks, and faucets.
2. Coordinate and review the Florida Building Code for the addition of more fixtures to meet the occupant count.
3. Provide ADA fixtures. This to be coordinated with structural or architectural modification.
4. Estimated repair cost = **\$6,000**

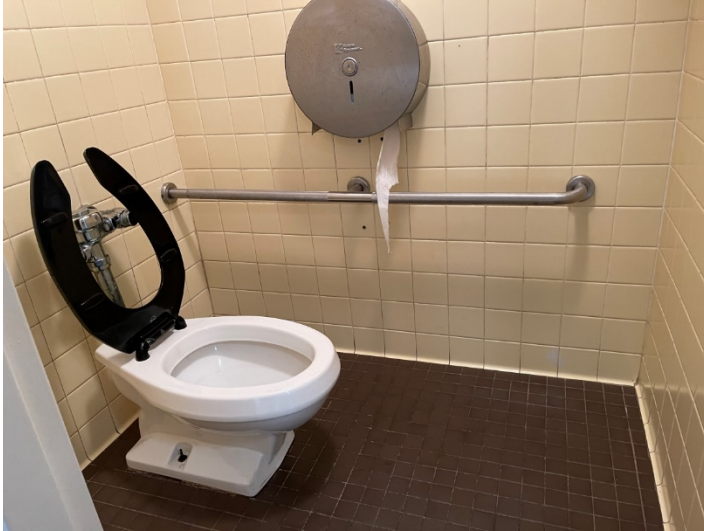
Non-ADA Compliant Restroom

| 4. Increase toilet size to meet ADA requirements | <b>\$32,000</b> |

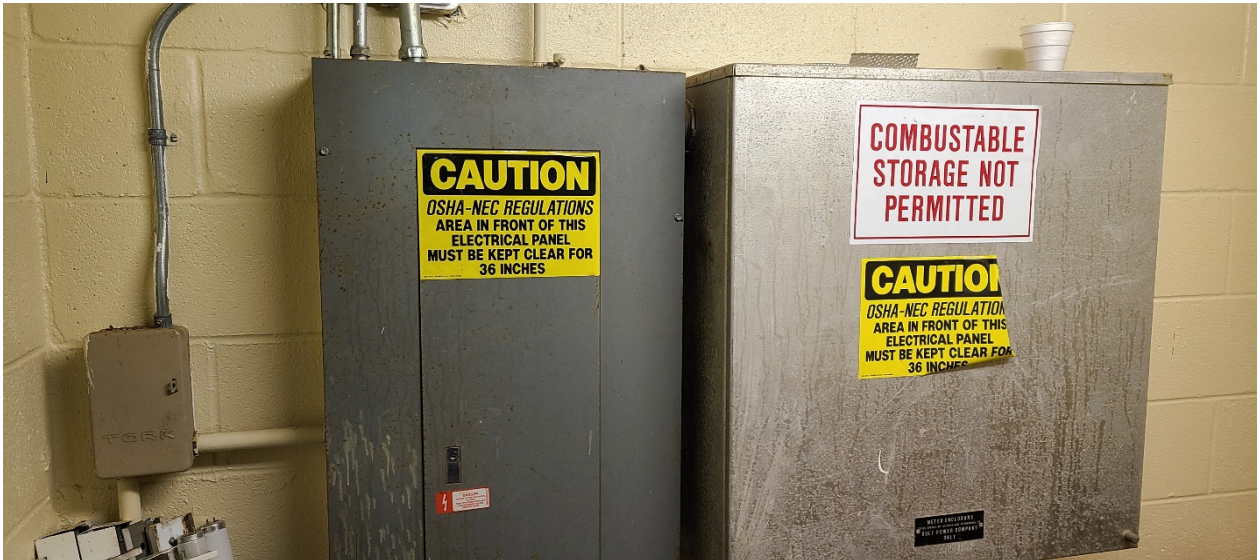
Main Panel

Building 10 has a 225-amp, 120/208-volt, 3 phase, 4 wire utility service. The entire building is served from the service panel. The service panel is considered at the end of usable life and should be replaced with any future renovation.

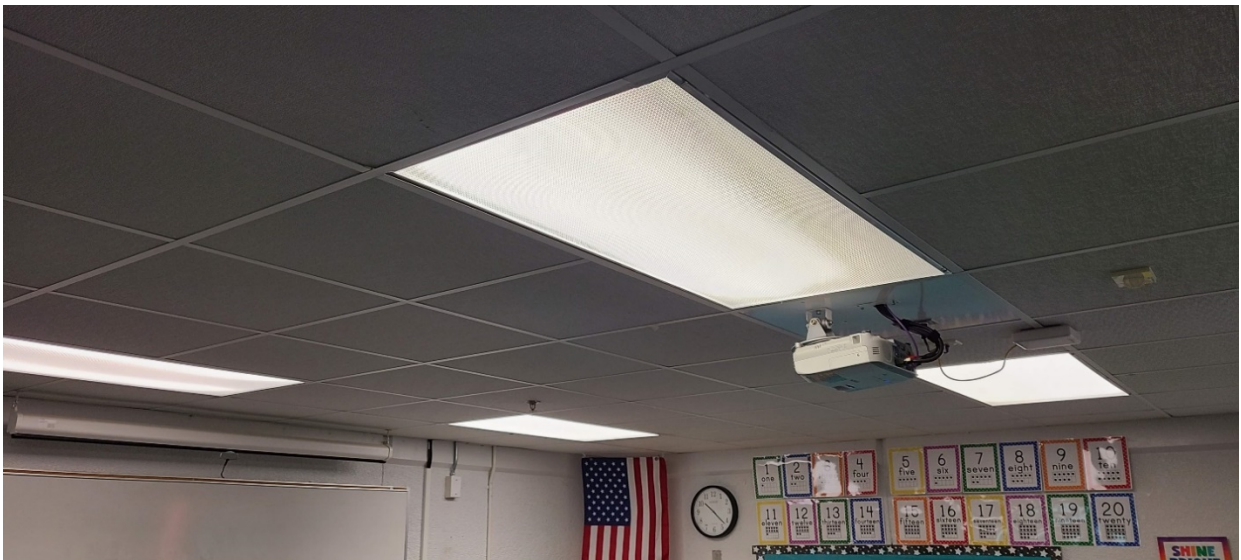
General Lighting Fixtures

The existing light fixtures appear to have been retrofit with LED light sources. Light fixture housings show signs of deterioration with visible rust and moisture damage. It is recommended that all light fixtures be replaced with any future renovation. There is no life safety egress lighting in building 10. Life safety egress lighting must be added. Lighting controls are not code compliant. Lighting controls will be required to be upgraded with any future renovation.

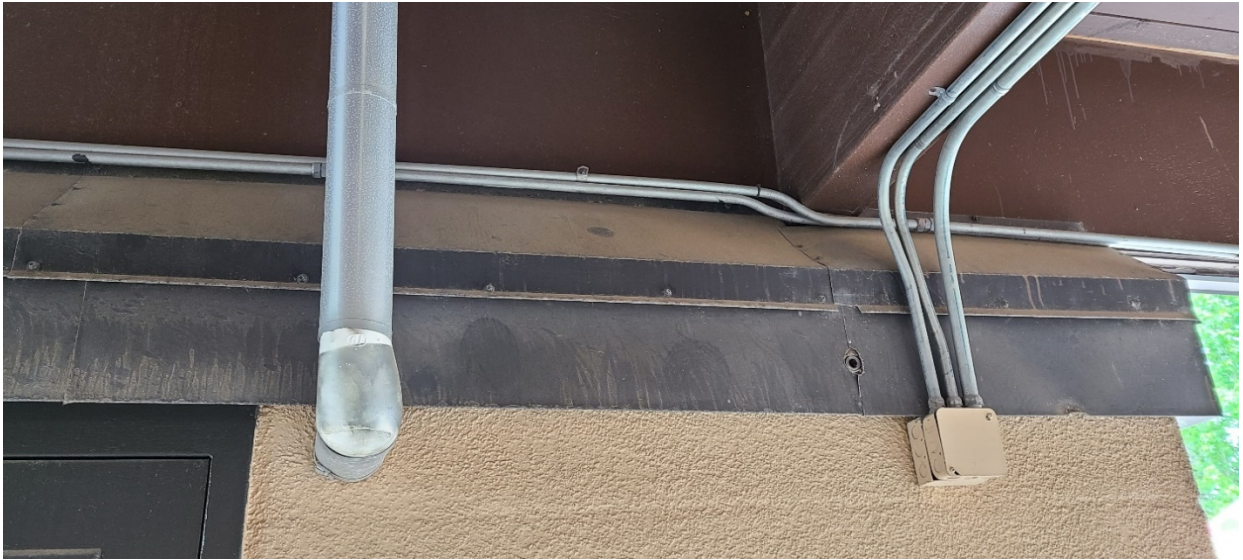
The electrical systems throughout the facility utilize surface raceways. It is recommended that all raceways be concealed during any future renovations. Many exterior exposed raceways are constructed from electric metallic tubing (EMT) type conduit, which is not permitted in this application. All exposed raceways should be replaced with a conduit suitable for this application with any future renovation.

Exterior Exposed EMT Raceways

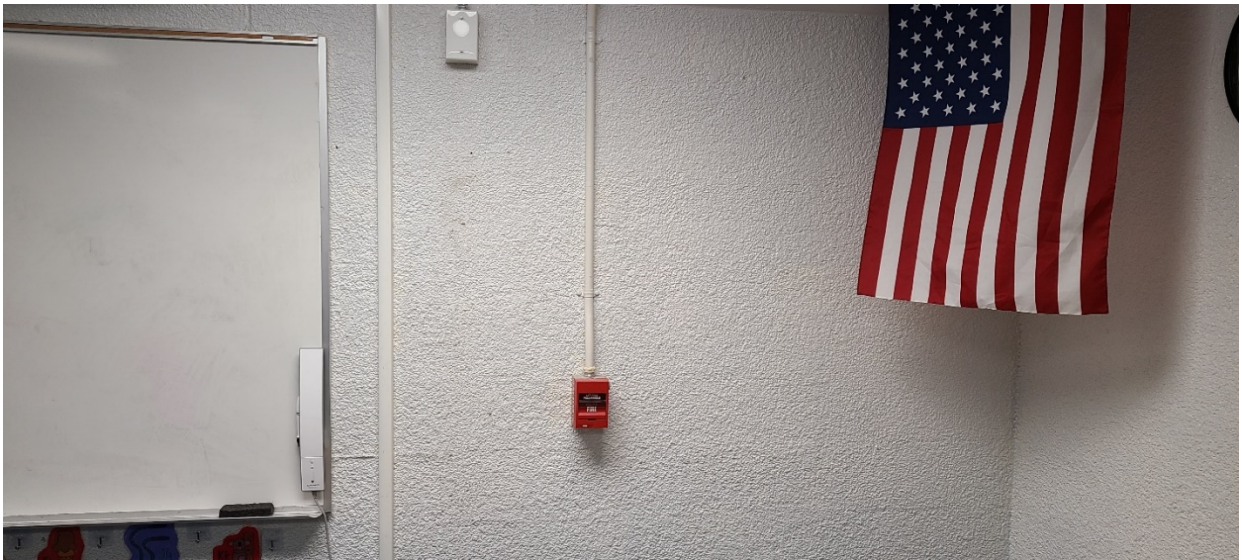
Interior Surface Raceways
