## Milton High School

BUILDINGS 3, 6, 11 & 17  
EXISTING CONDITIONS AND CASTALDI STUDIES

MARCH, 2021

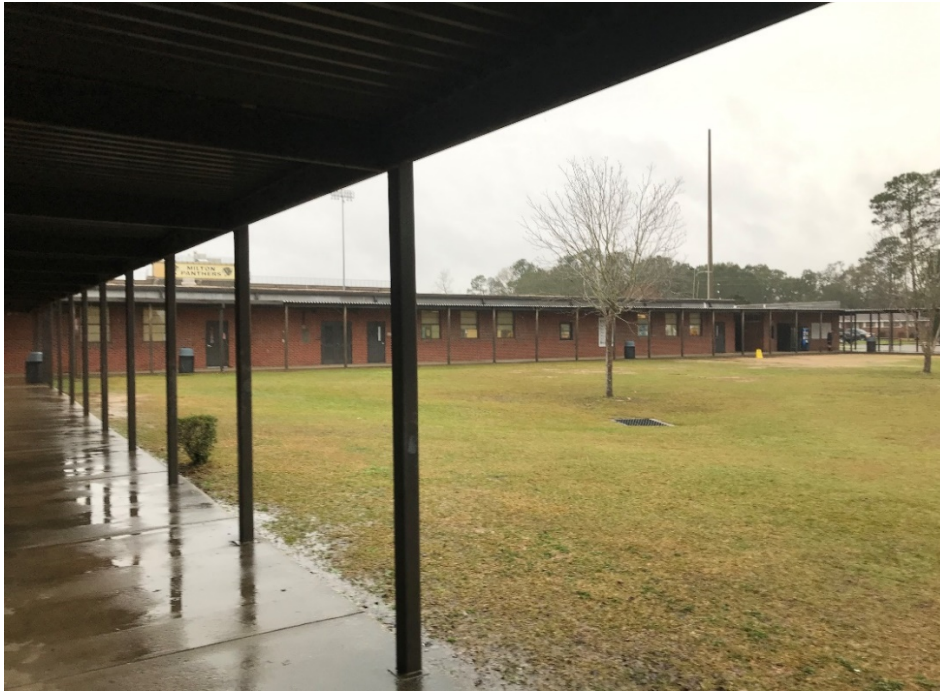
**Building 3 from walkway**

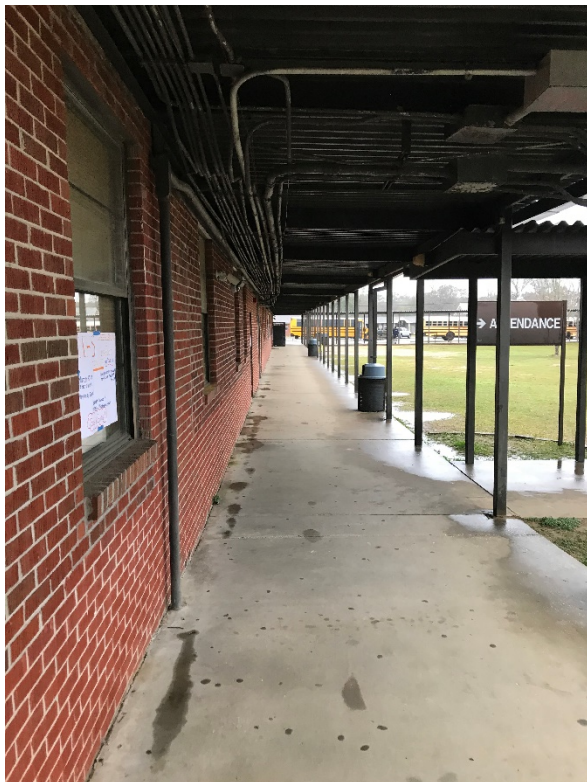
**Building 3 exterior covered walkway**

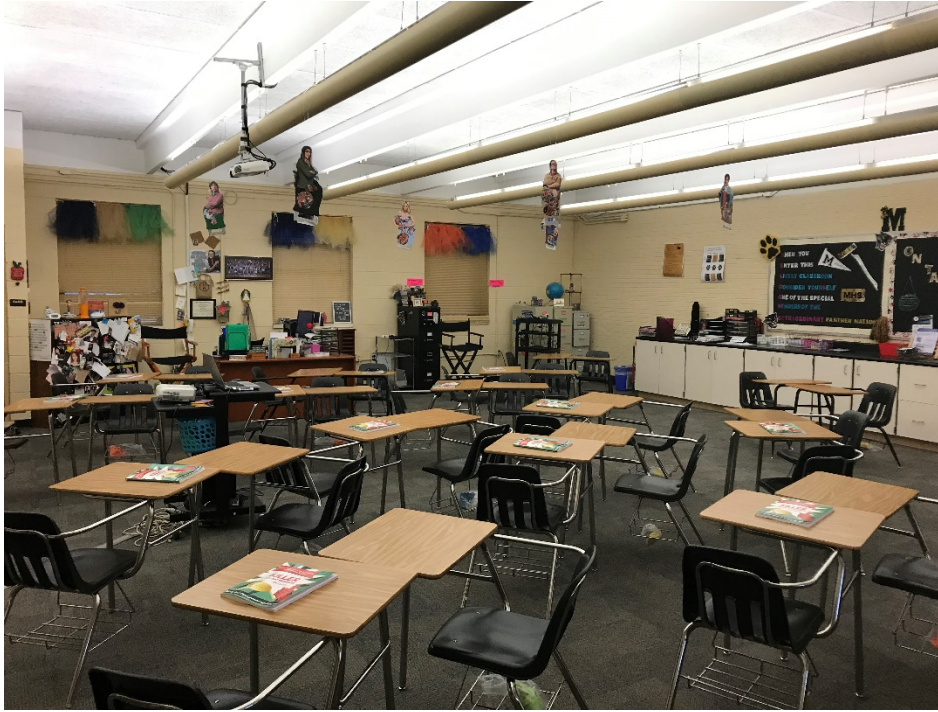
Building 3 is in poor structural shape. Roof precast tee beam ends need repair. Brick mortar joint damage needs repair and it appears that the exterior brick masonry is load bearing in conjunction with the block masonry. We are of the opinion that the roof construction types are incapable of resisting the current calculated wind loads. Further, the existing bearing masonry walls are likely unreinforced and inadequate to resist current code design lateral wind loads.

**Interior with precast structure**

Recommendations for repair include augmenting the existing roof structure and reinforcing exterior bearing walls. Existing footings may need to be modified as well.

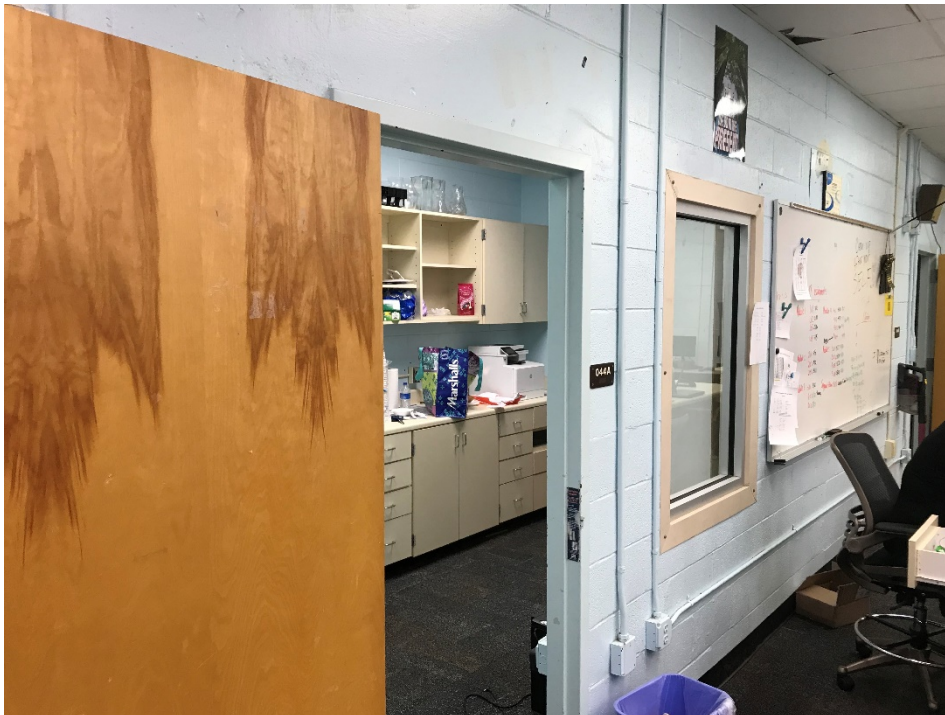
**Interior wall**

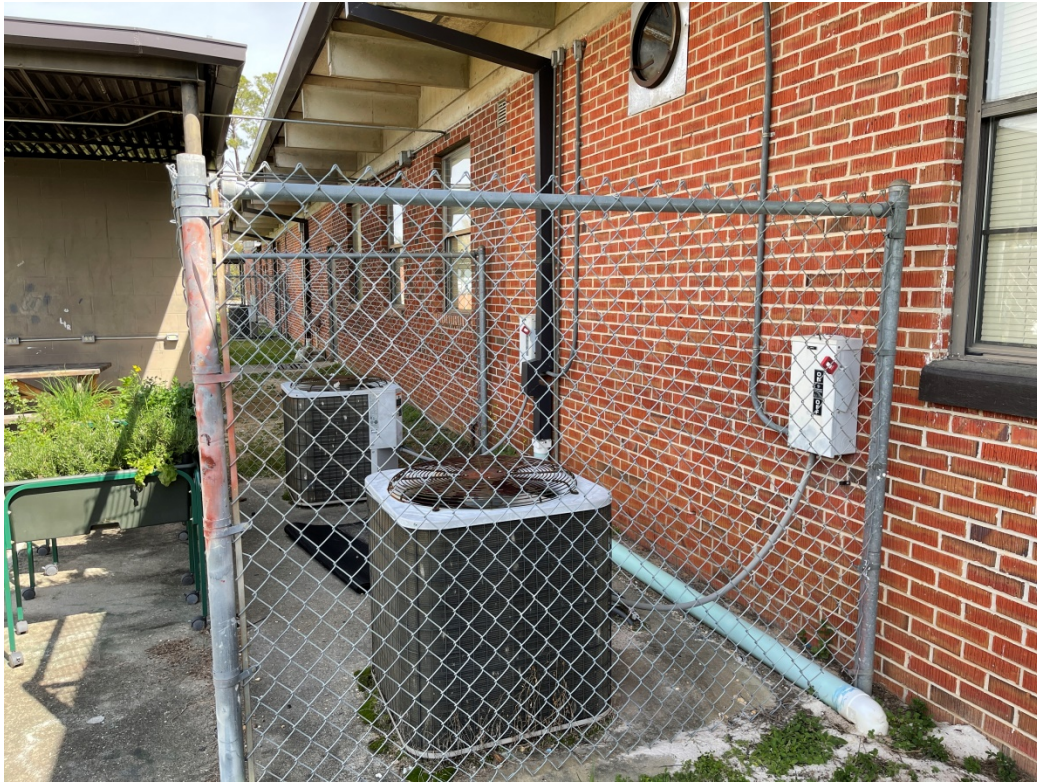
The existing systems are functioning but are well beyond their useful service life. Typical median life of DX packaged equipment is about 15 years. There is no control of indoor humidity or active dehumidification. These existing units are not up to current codes for ventilation, service, and safety standards. There is no outside air ventilation to this building. In order to bring the HVAC system up to current codes and standards, the following needs to be performed:

**Outdoor HVAC Units**

1. Replace HVAC system serving this building complete with high efficient units. Provide building DDC (Direct Digital Controls) system with new code compliant system(s). System would need to be provided with modern BACNet architecture as part of any upgrade. Web based energy management software permits oversight of component status but provides limited to no ability to change set point or schedule operation.

4. The equipment should be replaced with new classroom hydronic fan coil unit (e.g., Temspec to match the rest of the campus classroom wing) as part of any substantial facility renovation. Highly recommend connecting the new equipment to the existing campus wide chilled water and hot water loops.

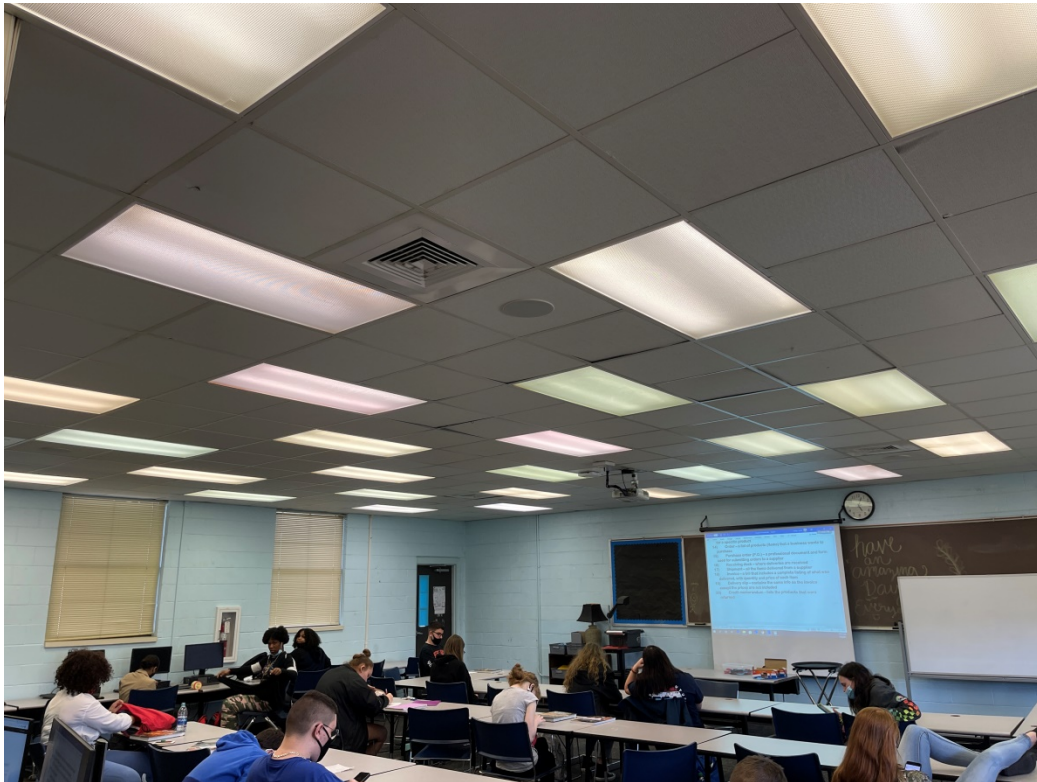
**Typical classroom with ceiling supply grilles**

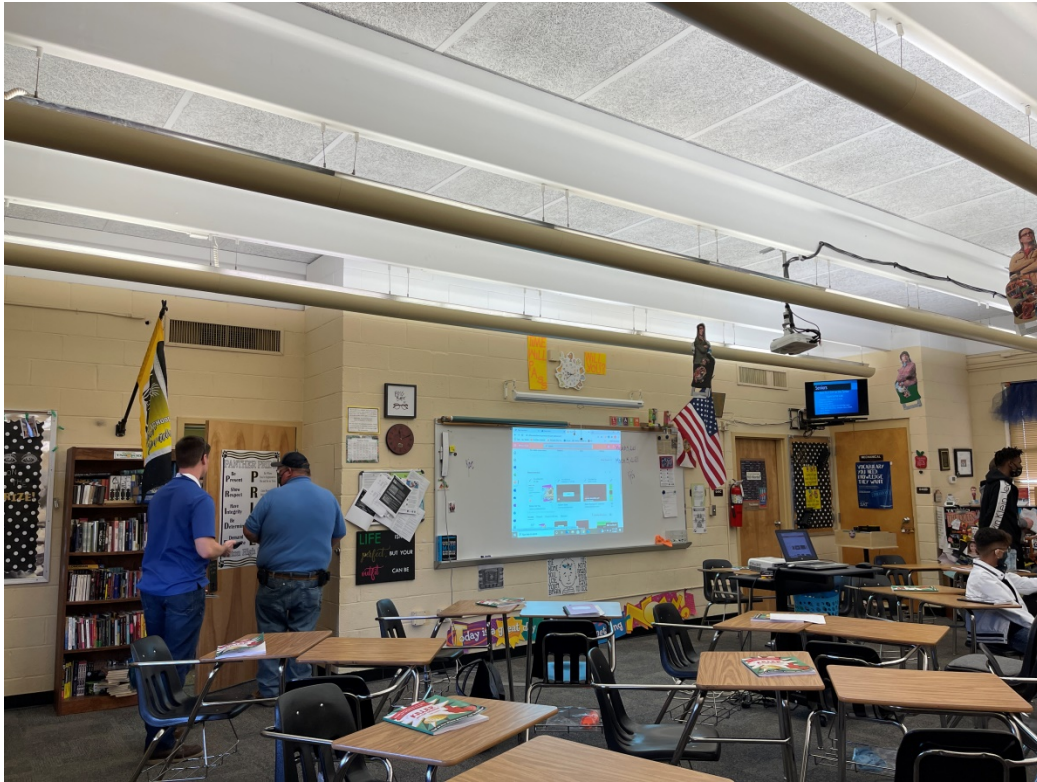
**Typical classroom with sidewall supply grilles**

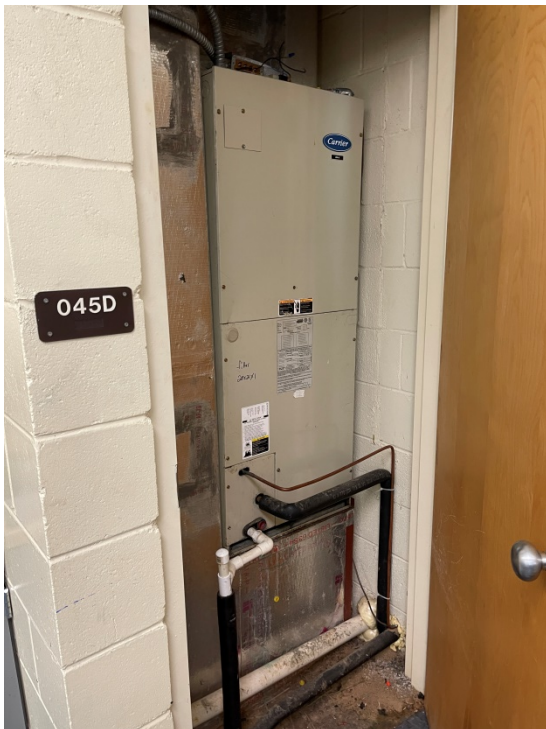
**Typical split system heat pump with base return plenum made of fiberboard. There is no outside air to each classroom**

2. The new system(s) will supply all spaces with the proper dehumidified outside air. Provide outside air per ASHRAE 62.1 standard.
3. A comprehensive review of the new systems would be performed in order to verify compliance with the 2020 FBC Energy Conservation Code.

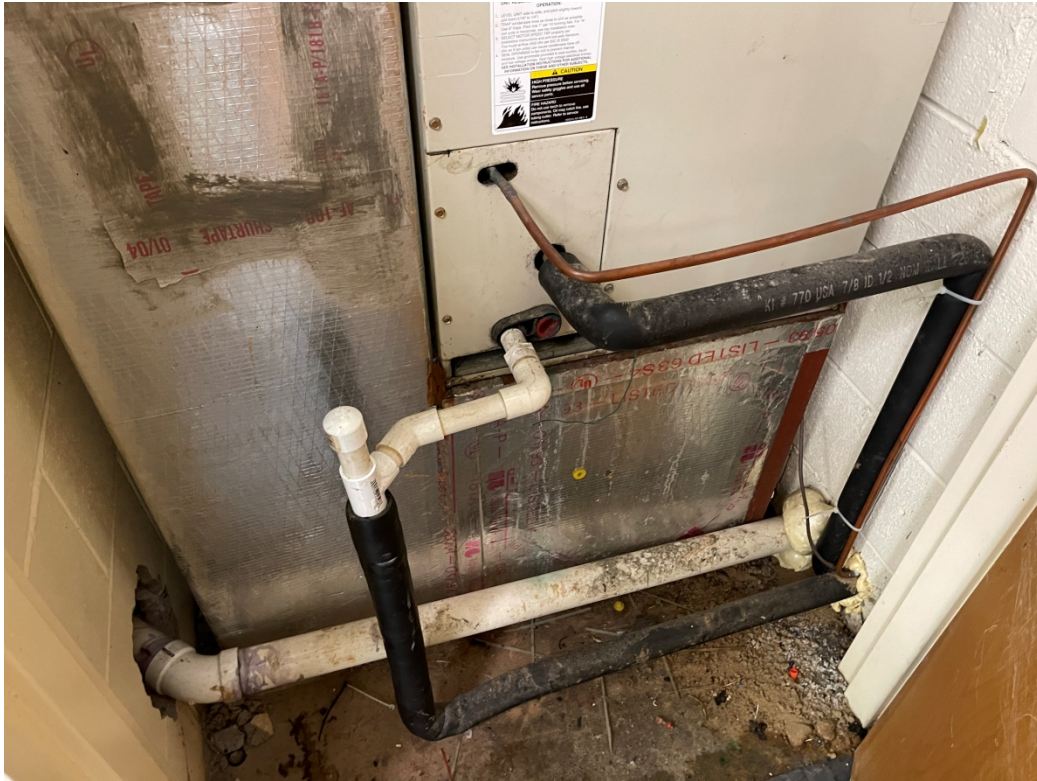
**Typical condensate drain on each AHU**

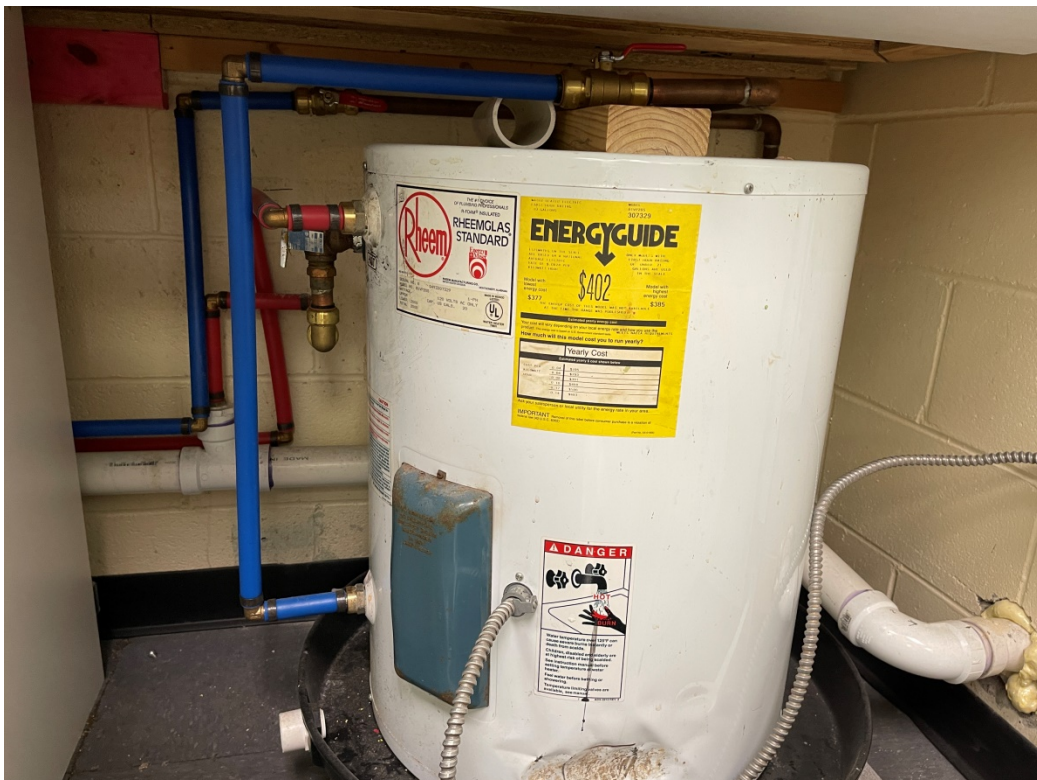
Plumbing fixtures are all showing signs of failure and need to be replaced. Most of the remaining fixtures should be replaced based on their useful life. There is plumbing infrastructure within the building that appears original to the construction of the building. The plumbing fixtures within the building are out-of-date, and not per the current school district design standards.

**Water heater with no mixing valve**

1. Replace all the plumbing fixtures and infrastructure piping. Provide new accessories, faucets and for the new fixtures.
2. Provide new water heater with mixing valve to prevent legionella growth inside the tank.
3. Coordinate and review the Florida Building Code for the addition of more fixtures to meet the occupant count.
4. Estimated repair cost = **\$4,000**

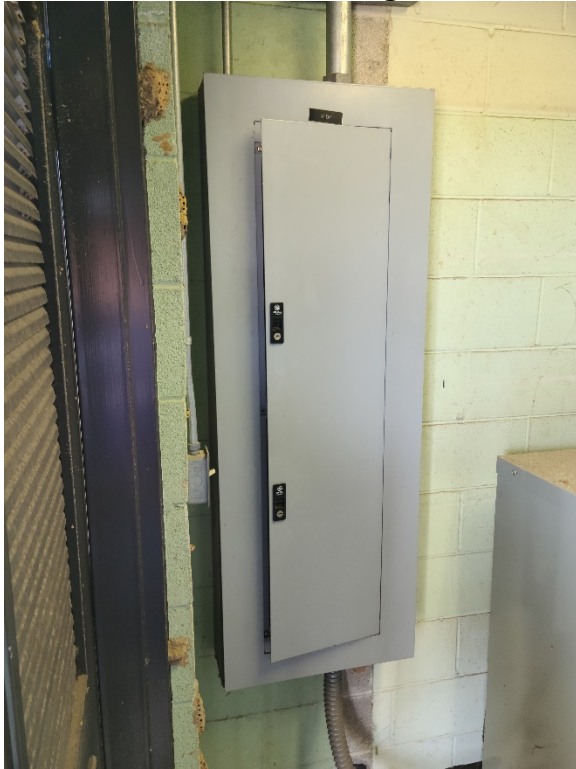
Building 3 at Milton High School (MHS) has a 480/277-volt 3 phase electrical system. It is served from the campus central plant switchboard. The main electrical gear should be considered at the end of its usable life. All equipment should be replaced with any major renovation. There are multiple panels recessed in exterior walls, exposed to the elements. All of these panels are in critical condition and should be replaced.

**Building 3 main gear**

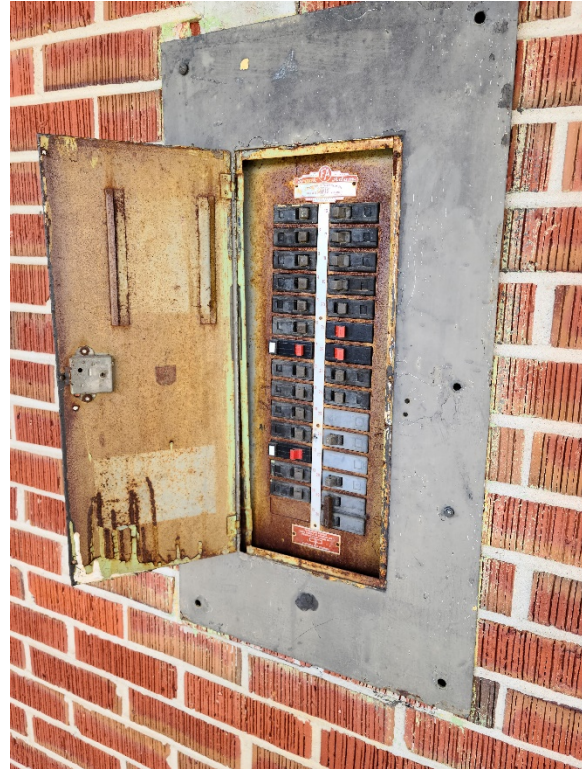
**Exterior recessed panel**

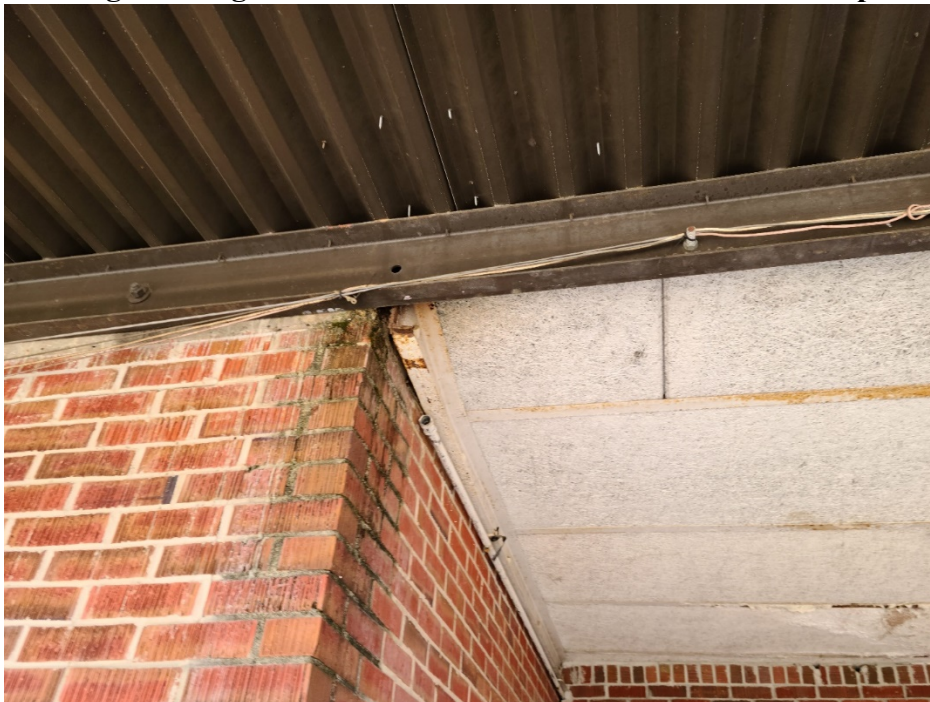
The building electrical devices utilize surface raceways in many areas throughout the building, both interior and exterior. Many raceways are not suitable for their environment – i.e., type EMT conduit is used exposed exterior. Surface raceways should be installed concealed where able, repaired, and installed with an adequate material for the environment it is in on any future renovation.

**Insufficient exterior surface raceways**

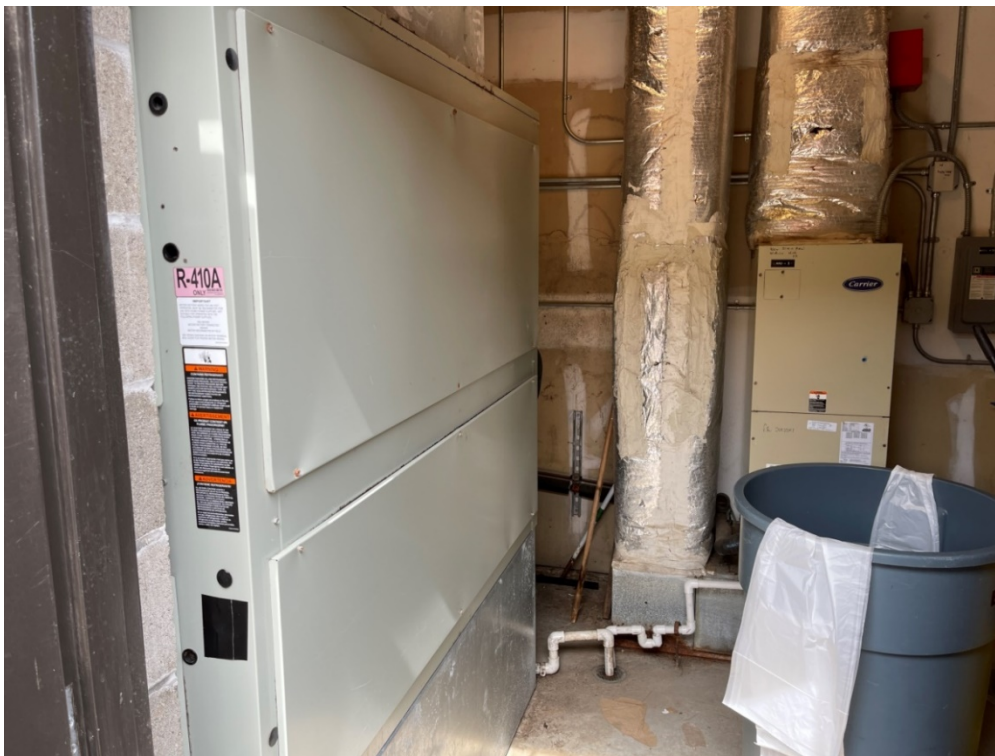
Existing split system DX inside mechanical room

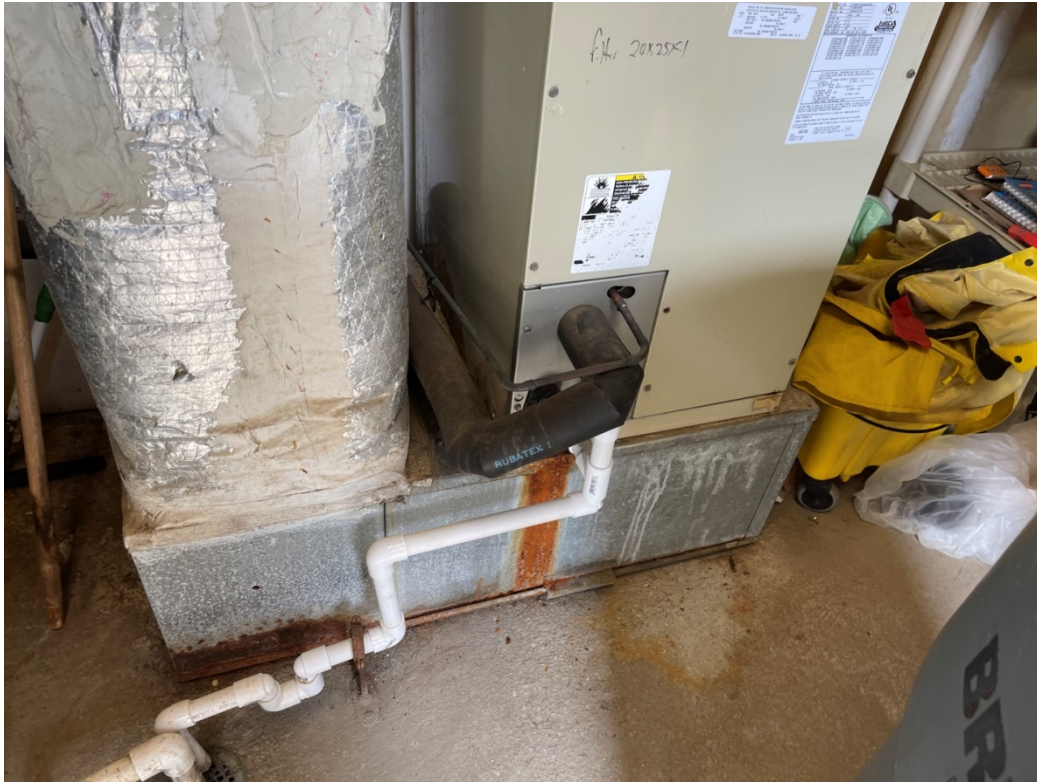
Existing split system DX inside mechanical room. AHU filter box needs to be replaced for better indoor air quality.

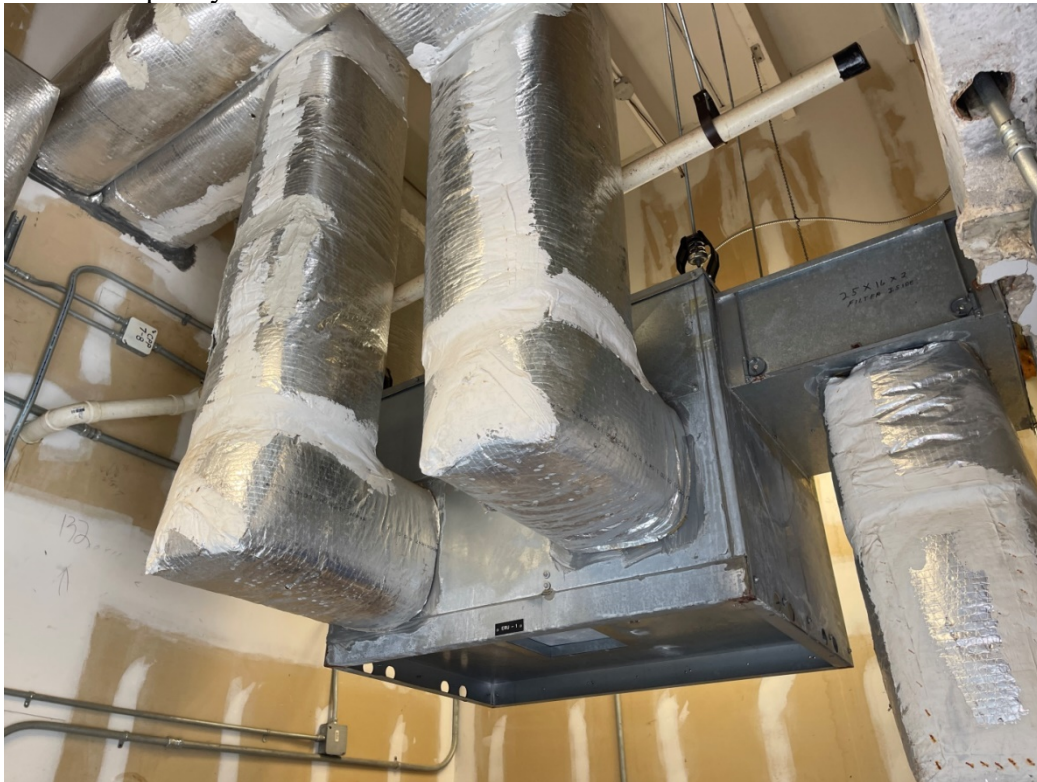
Energy recovery unit inside mechanical room

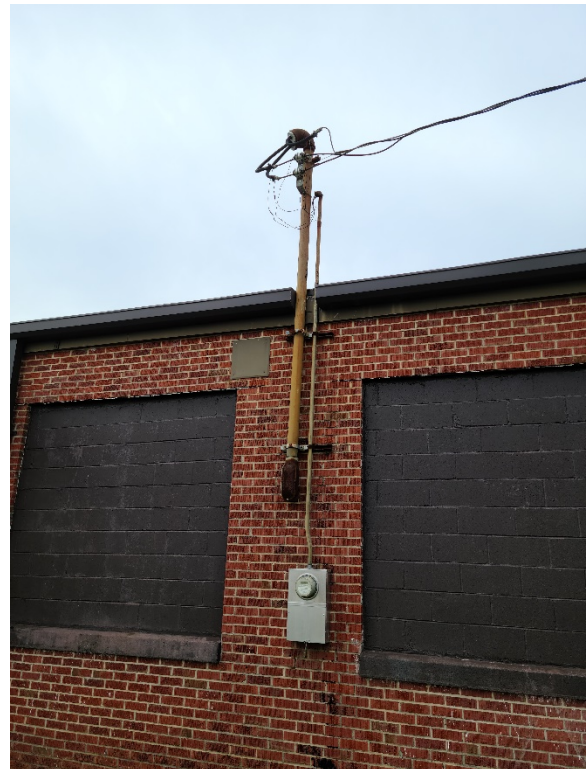
Building 6 at Milton High School (MHS) has 2 electrical services. The first is a 208/120-volt 3 phase electric system. It was not clear during the inspection where this service is supplied from. There is an existing single phase overhead service on the east side of the building serving the east half of the building. The single-phase service is in inadequate condition and should be removed and replaced with any future renovation. Electrical equipment labeling is not code compliant and should be updated with any future renovation. It is recommended that the building be converted to a single service in any major future renovation. The single-phase service should be removed, and the 3-phase service be upgraded to serve the entire building.

Single phase service

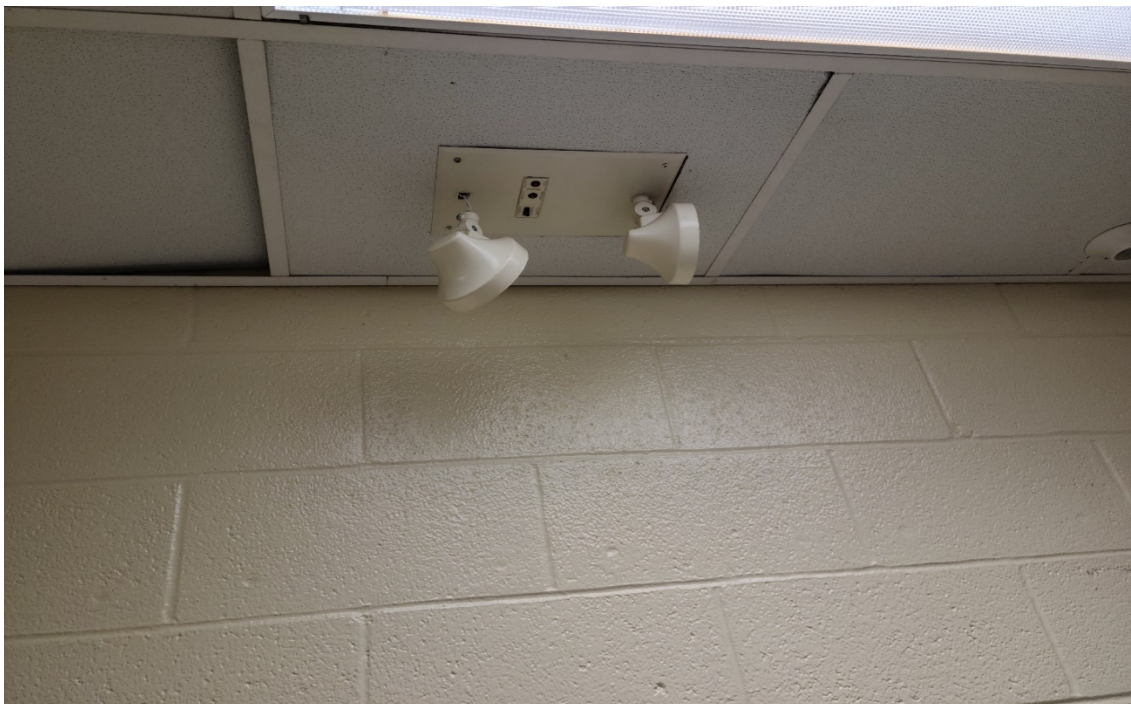
Building 6 does not have sufficient life safety egress lighting. Some battery pack lights were visibly damage, and there are not enough for sufficient lighting as recommended by IES. Egress lighting will be required to be replaced with any future renovation.

Damaged emergency lighting

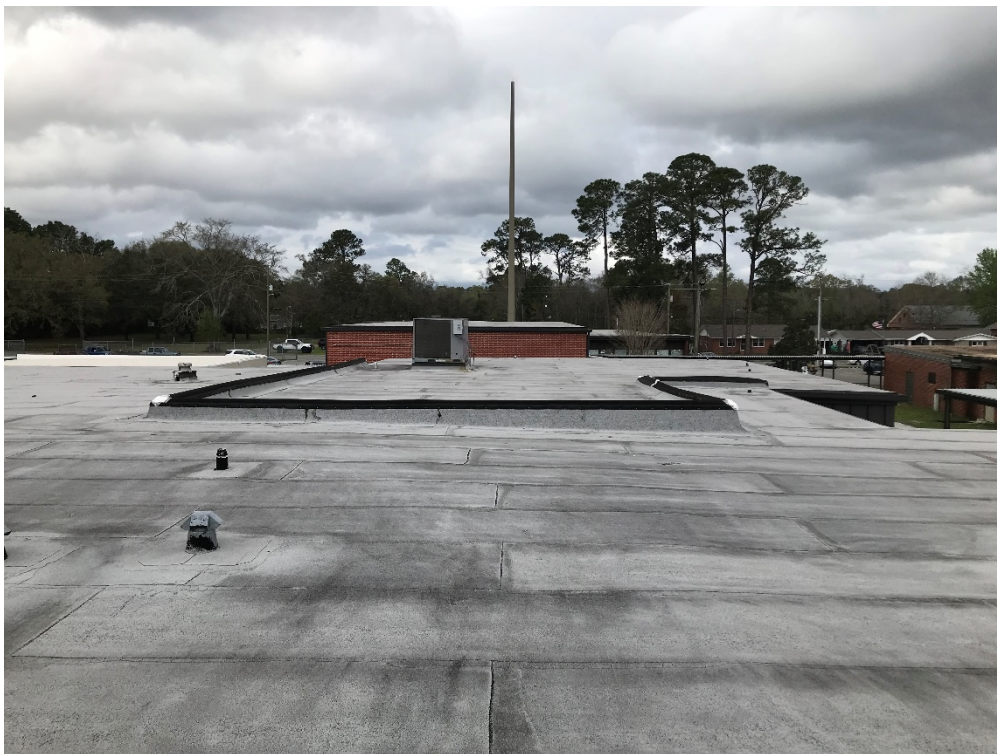
The building has a granulated surface membrane cap sheet roof. The existing roof slope is most likely created from either lightweight insulating concrete or tapered roof insulation. This type of roof is typically inadequate as a long-term solution. The perimeter of the roof has aluminum gutter and downspouts. The downspouts are tied into an underground collection system. There is one rooftop unit and other than roof vents there are no roof penetrations. There is a building expansion joint with appropriate bellows type roof expansion joint visible on this roof.

Building 11 Roof

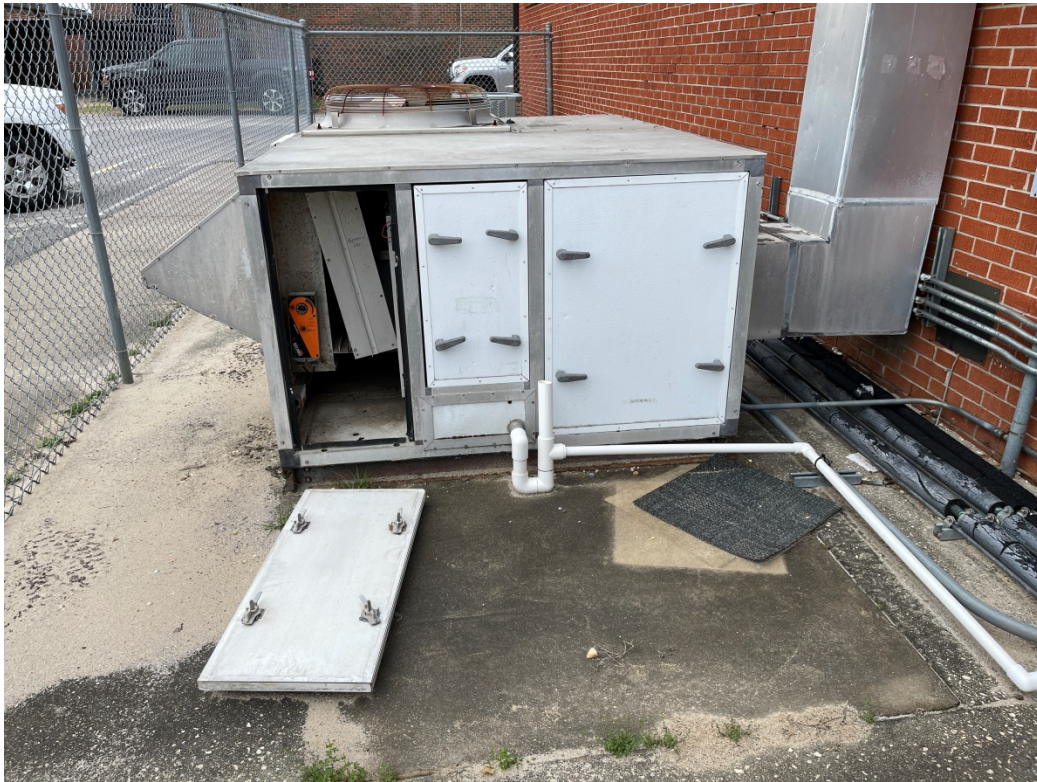
Dedicated outside air unit with exterior ductwork

1. Replace ductwork system with exterior insulated metal ductwork as needed.
2. Replace HVAC system serving this building complete with high efficient units. Provide building DDC (Direct Digital Controls) system with new code compliant system(s). System would need to be provided with modern BACNet architecture as part of any upgrade. Web based energy management software permits oversight of component status but provides limited to no ability to change set point or schedule operation.

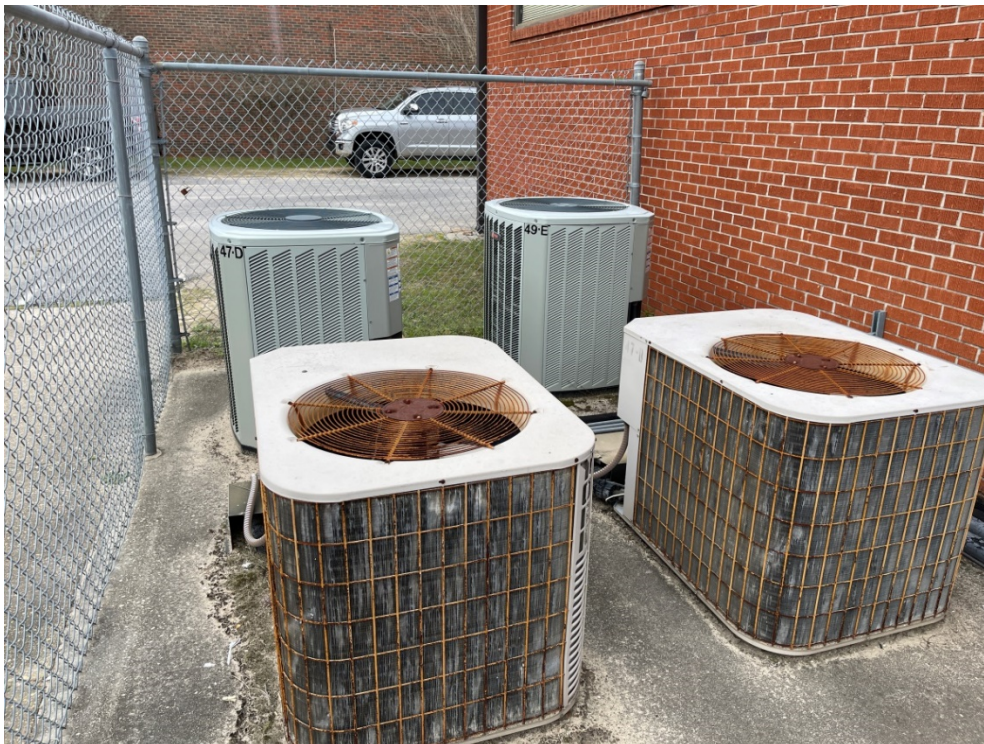
Some of the existing system appears to have several more years of its useful service life while some of them have passed their useful life. A typical median life of DX split system equipment is about 15 years. Without a proper Test and Balance report, the units outside air rate could not be verified if it's not up to current codes or not. The equipment condition is serviceable and could be reused as part of the substantial facility renovation. In order to bring the HVAC system up to current codes and standards, the following needs to be performed:

Units needing replacement

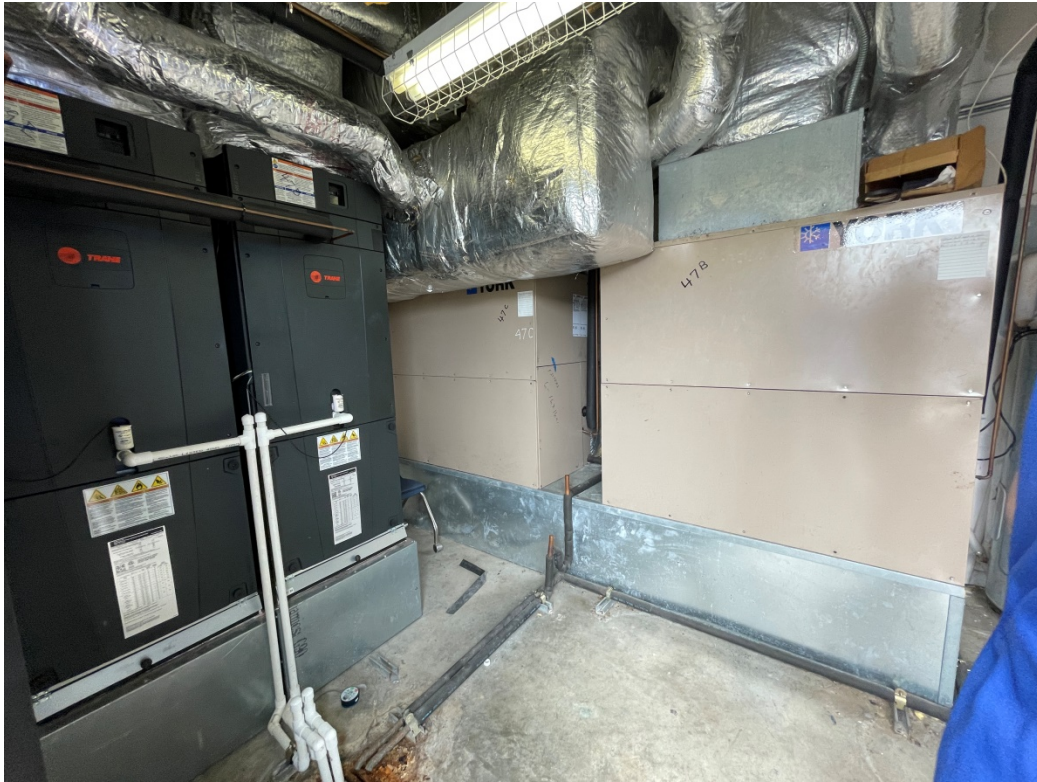
The two units on the right might need to be replaced within several years. The two units on the left still have at least 12 more years of equipment life.

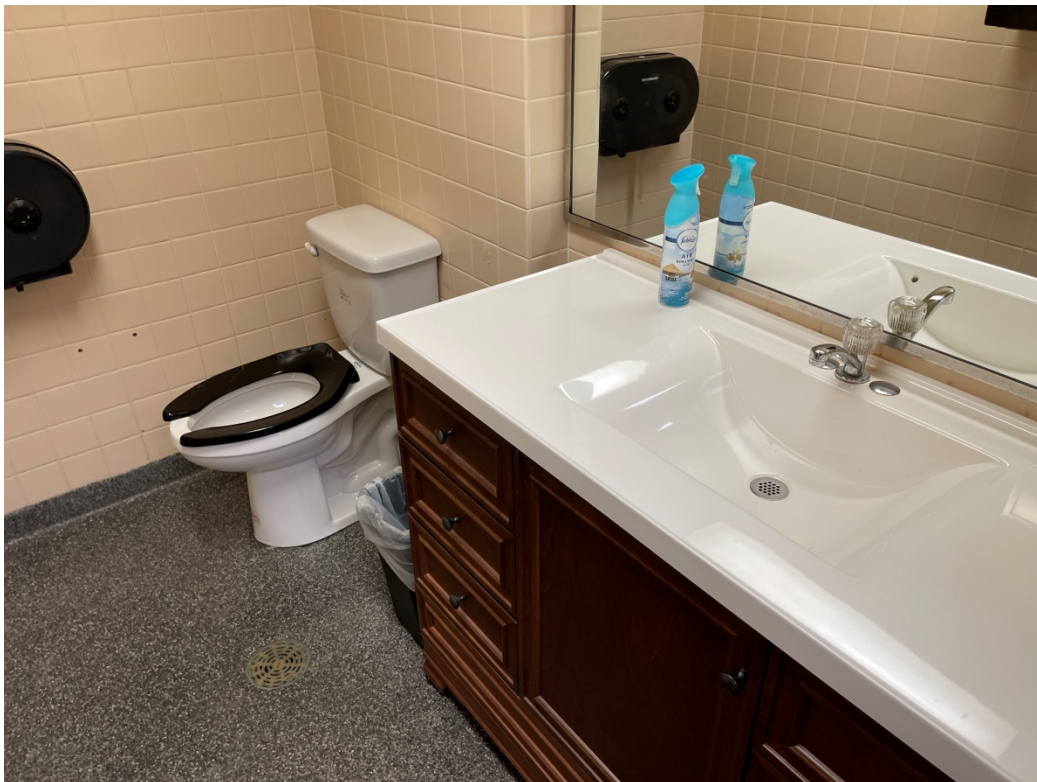
Some of the plumbing fixtures with the exception of the home economic labs are outdated and need to be replaced. Most of the remaining fixtures should be replaced based on their useful life. There is plumbing infrastructure within the building that appears original to the construction of the building. The building mainly is served by an electric water heater located inside the

Outdated plumbing fixtures

1. Replace some of the plumbing fixtures and infrastructure piping. Provide new accessories, faucets, and flush valves for the new fixtures.
2. Coordinate and review the Florida Building Code for the addition of more fixtures to meet the occupant count.
3. Estimated repair cost = **\$4,500**

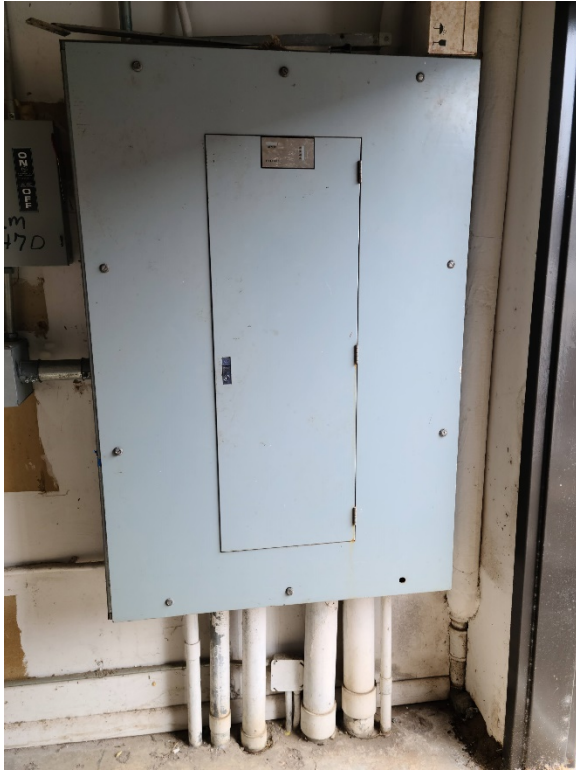
Building 11 at Milton High School is served from a 208/120-volt 3 phase service. The utility transformer is located directly south of the main electric room. The main gear is at the end of its usable life and should be replaced with any major renovation. Sub panels throughout the building are also at the end of their usable life and should be replaced with any major renovation.

Main panel

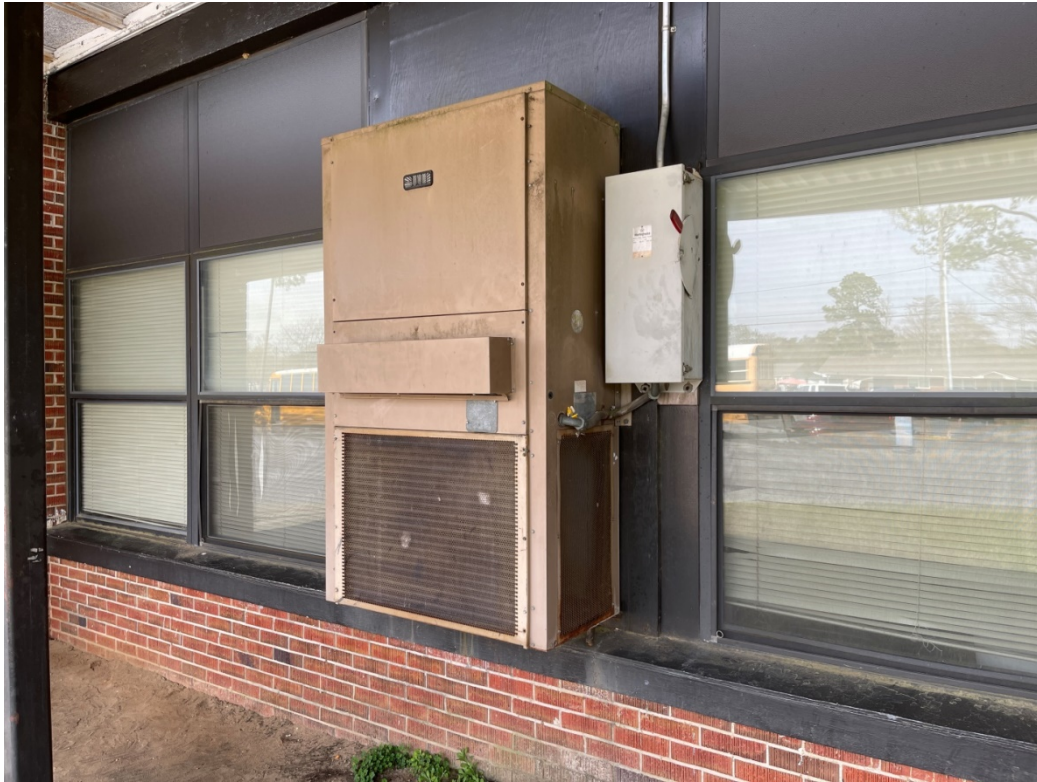
Wall mounted HVAC unit

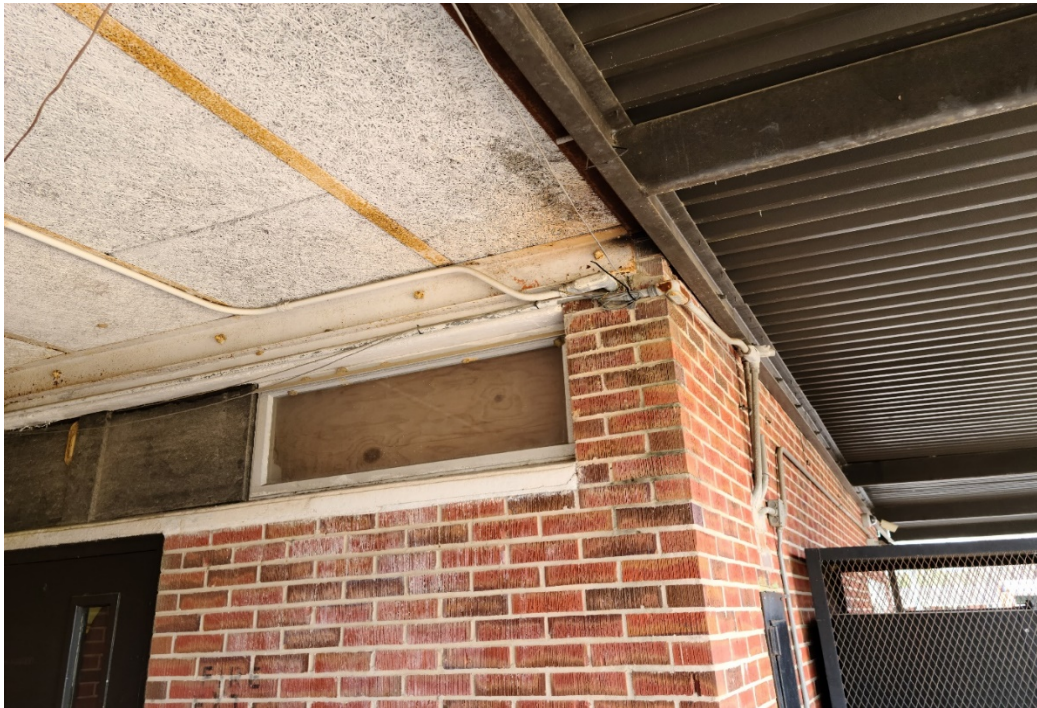
Surface mounted raceways
