**RE: 6032 Highway 90, Milton, Florida, 32570
Summary of Findings - Preliminary Storm Water Investigation**

Summary of Findings - Preliminary Storm Water Investigation

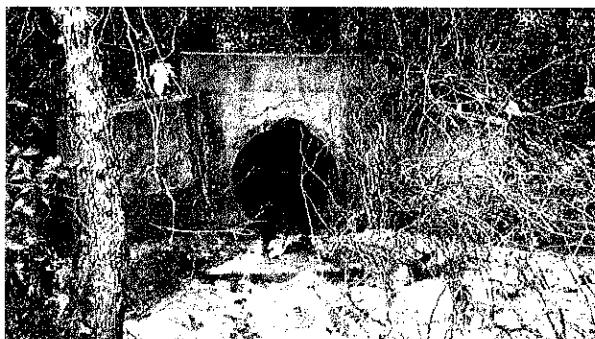
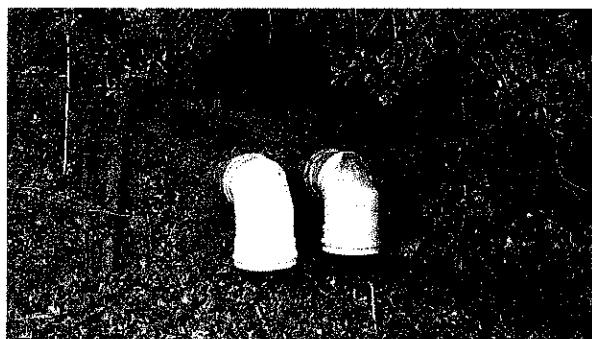
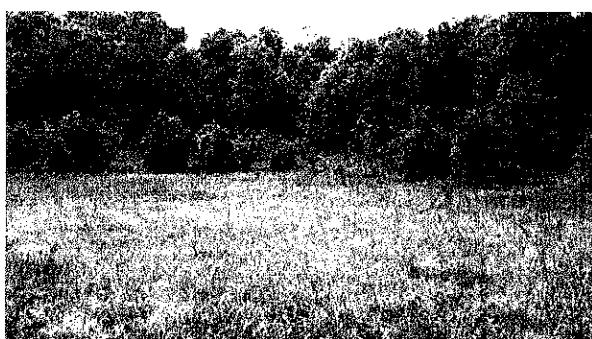
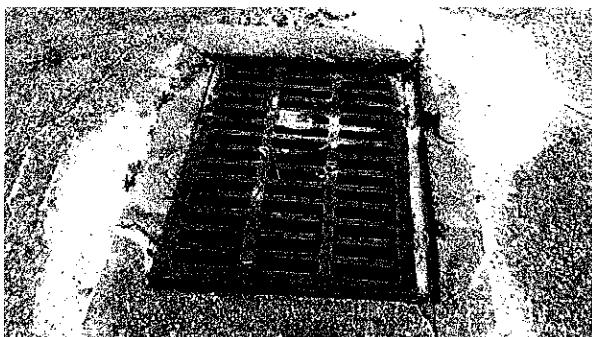
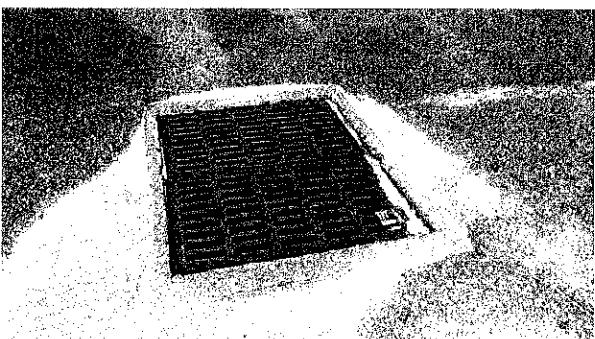
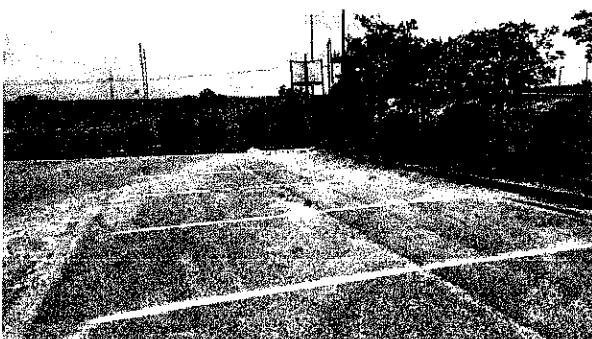
Exhibit C: Photos of Observed Site Conditions

A field inspection was performed to observe and document the existing site conditions and pictures reflecting the observed conditions are included in Exhibit C. For the most part it appears as though the on-site collection system is in fair condition. The actual piping was not televised or visually inspected but there are no signs the system is blocked or has suffered any failures in its integrity. There is some debris that has collected around the open inlet tops system but this would only requires minor, routine maintenance to resolve. The storm water ponds do not appear to have been routinely maintained in the way of removing debris and controlling vegetation and there are a substantial number of smaller trees within the limits of the ponds that need to be removed. Historical permitting records indicate the Food World storm water pond was designed with a sand filter-drain system. It was not possible to confirm determine the integrity of this underground system, and based upon visual observation of the pond holding a small amount of water the system appears to not be functioning completely as designed. Correction of this issue could be additional basic maintenance or in the worst case scenario the filter-rain system may need to be replaced.

It is our general opinion that the storm water system serving the Food World property is in fair condition and in substantial compliance with its original permit. The only area of significant concern is the sand filter-drain in the bottom of the pond that we feel requires at a minimum restorative maintenance and at worst complete replacement.

Typical clean-up and maintenance is required across the site, including removal of overgrown vegetation from the storm water pond and removal of accumulated sediment from the parking area and storm water structure.

Based upon quantity take-offs from the original construction plans, we estimate the costs of the noted maintenance and corrections to be as follows:

| 1. Clearing of pond vegetation/stabilizing - | 8,500 SY @ \$6.00/SY = \$51,000 |
| 2. Replacement of pond filter system - | 210 LF @\$25/LF = \$5,250 |
| 3. Repair of asphalt paving - | 250 SY @ \$25/SY = \$6,250 |
